<b>ESTUDIOS Y DISEÑOS PARA LA REHABILITACIÓN DE LA LÍNEA RED MATRIZ DE 78" TIBITOC - CASABLANCA</b>

<b>CONSORCIO TIBITOC 2006</b>	
<b>CONTRATO 1-02-25400-514-2006</b>	<b>PRODUCTO 6.3. INFORME DE CARACTERIZACIÓN ESTRUCTURAL DE LOS TRAMOS 1 Y 3</b>	<b>RTC-IF-ET-001</b>	<b>VERSIÓN: 1</b>
		<b>FECHA: 2008-11-26</b>

**ANEXO NO. 3. ENSAYO MORTERO DE RECUBRIMIENTO FALLA #1**

EXAMINATION OF MORTAR COATING SAMPLE  
FROM A FAILED PRESTRESSED EMBEDDED  
CYLINDER PIPE, BOGOTA, COLOMBIA

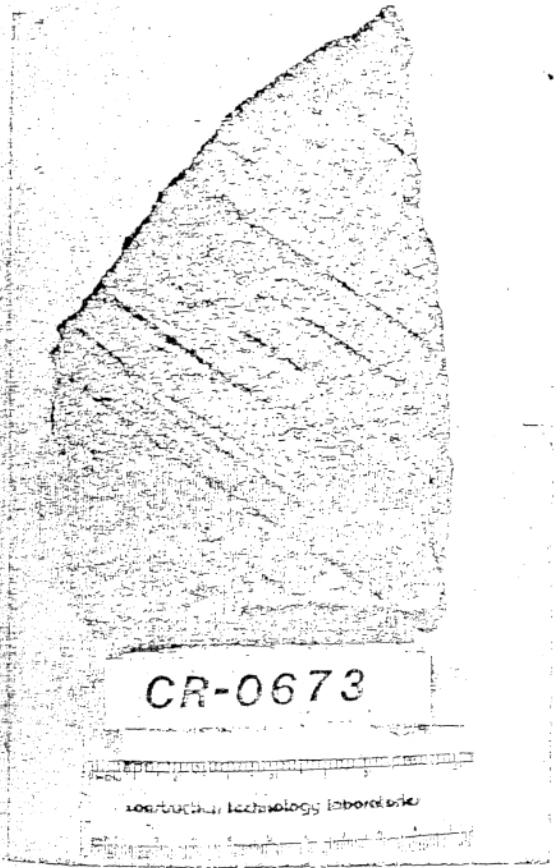
Exposed surface
