**MICHAEL S. HIGGINS TECHNICAL MEMORANDUM – PIPE G296**

SUBJECT: Excavation of Pipe Section G296

**MICHAEL S. HIGGINS TECHNICAL MEMORANDUM – PIPE B217**

SUBJECT: Excavation of Pipe Section B217

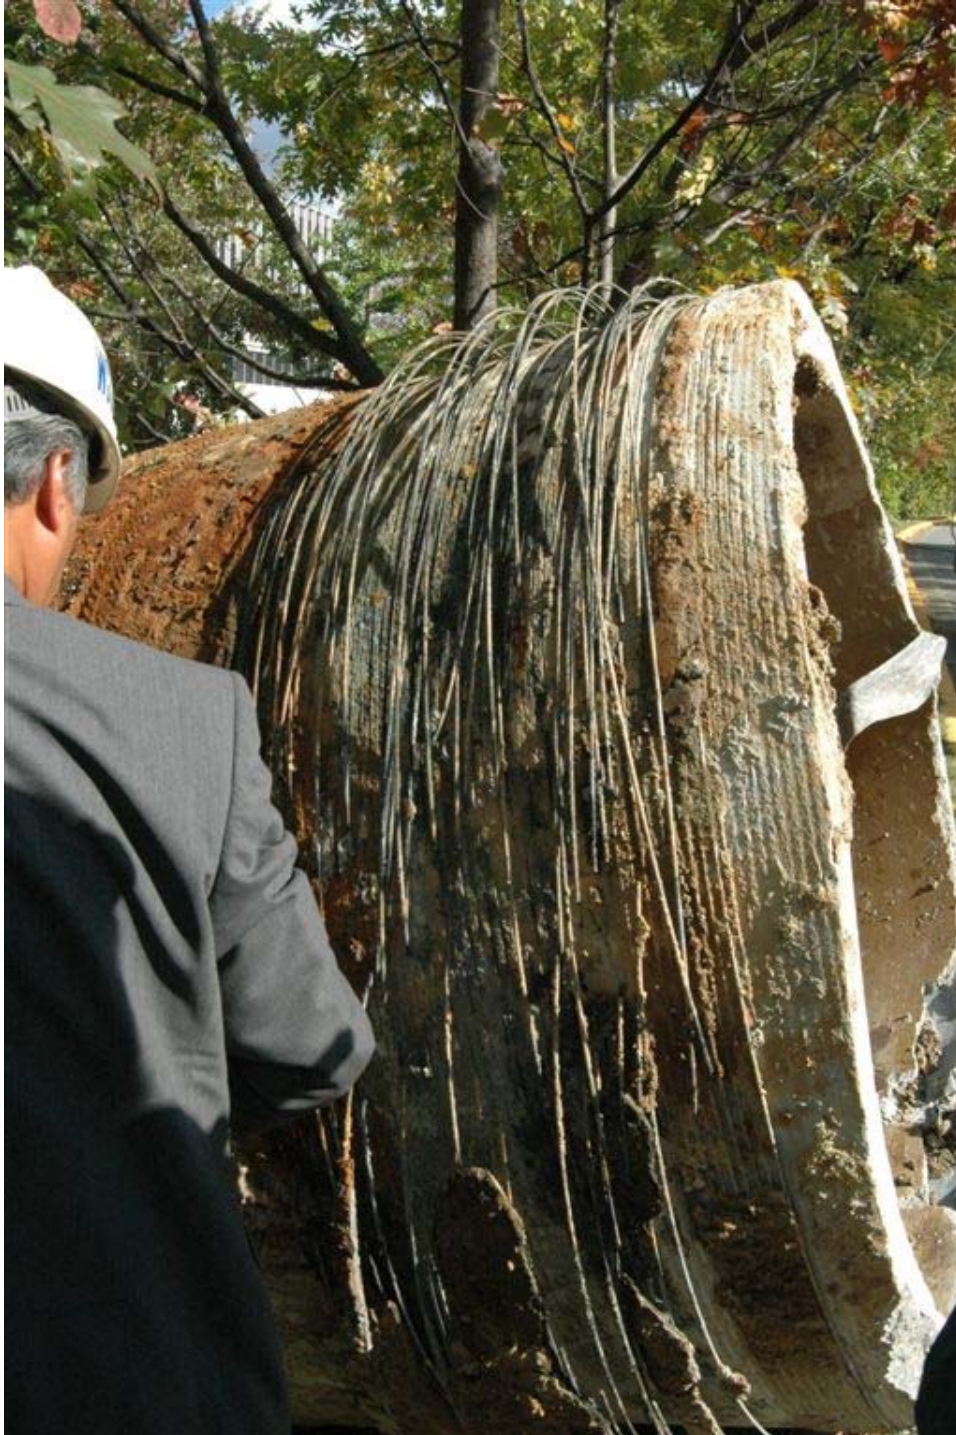
However, the bell portion of the pipe had obvious wire break damage. The bell portion was reportedly removed from the downstream (east) side of the pipe. Damage was observed on the south springline (this is based on the bell side being downstream). The bell portion of the pipe was approximately 6 feet long. Wire breaks were observed in the last 28 inches of the pipe. Further, the contractor reported that wire break damage also extended a couple of inches into the missing center piece of the pipe. Thus the total length of damaged pipe was approximately 30-inches. A small crack, approximately 6-inches long, was observed inside this pipe. The wire appeared black and there was not a significant presence of rust on the wires. The mortar coating appeared soft and thin in the area of wire break damage.

Wire Break Damage on the bell portion of the pipe section.

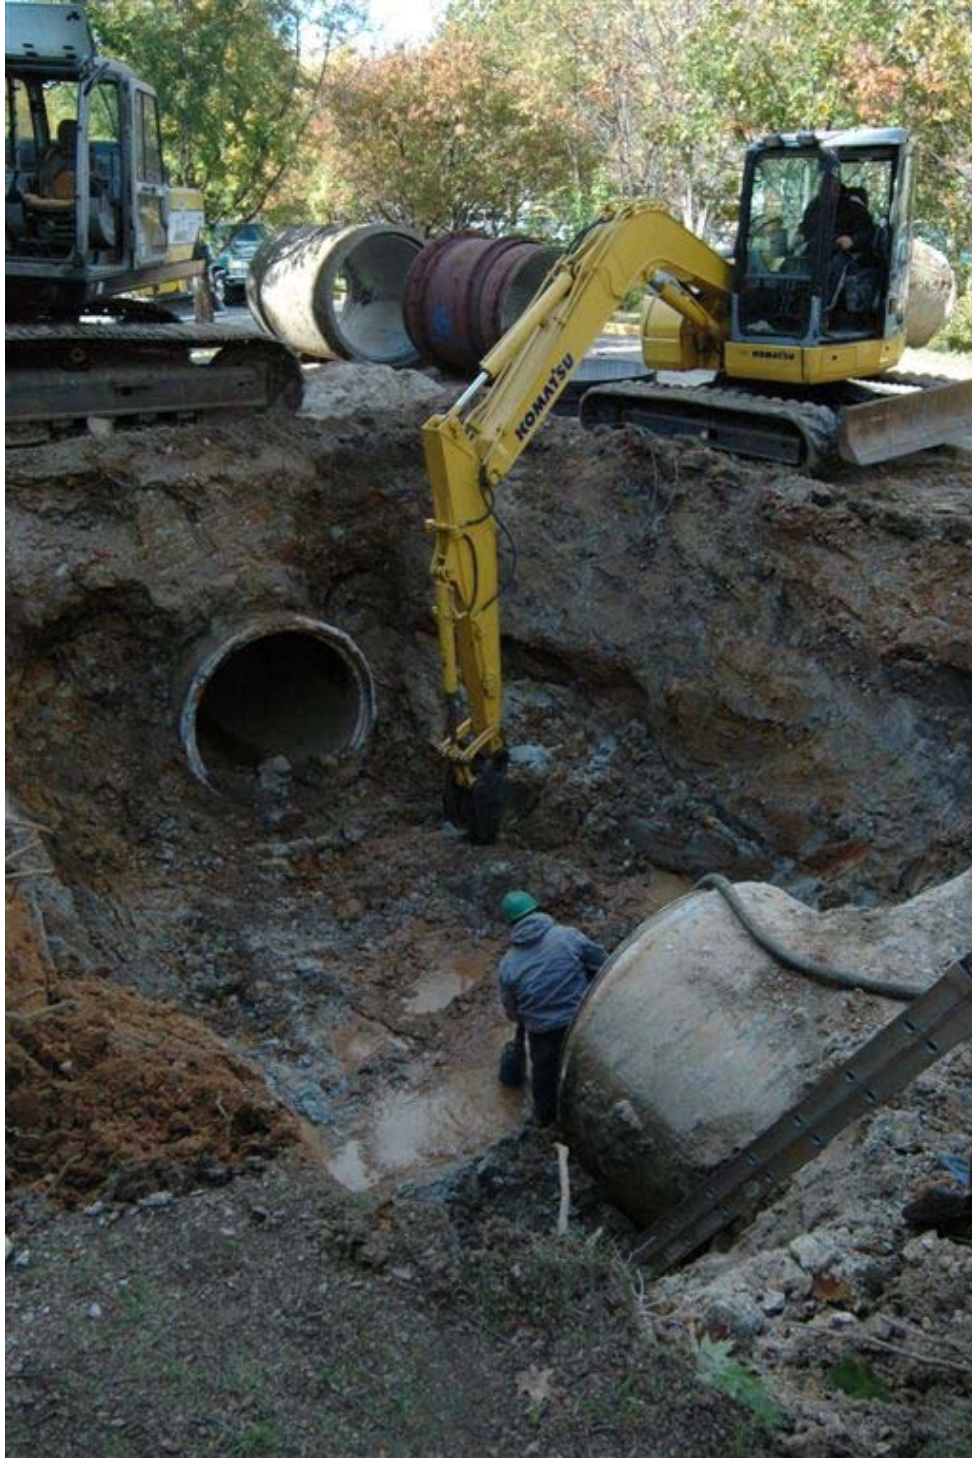
Photograph of the excavation. The pipe at the top of the photo is G295. It was confirmed that G295 was next to an air release valve, which is consistent with the inspection records. Thus the correct pipe was excavated.

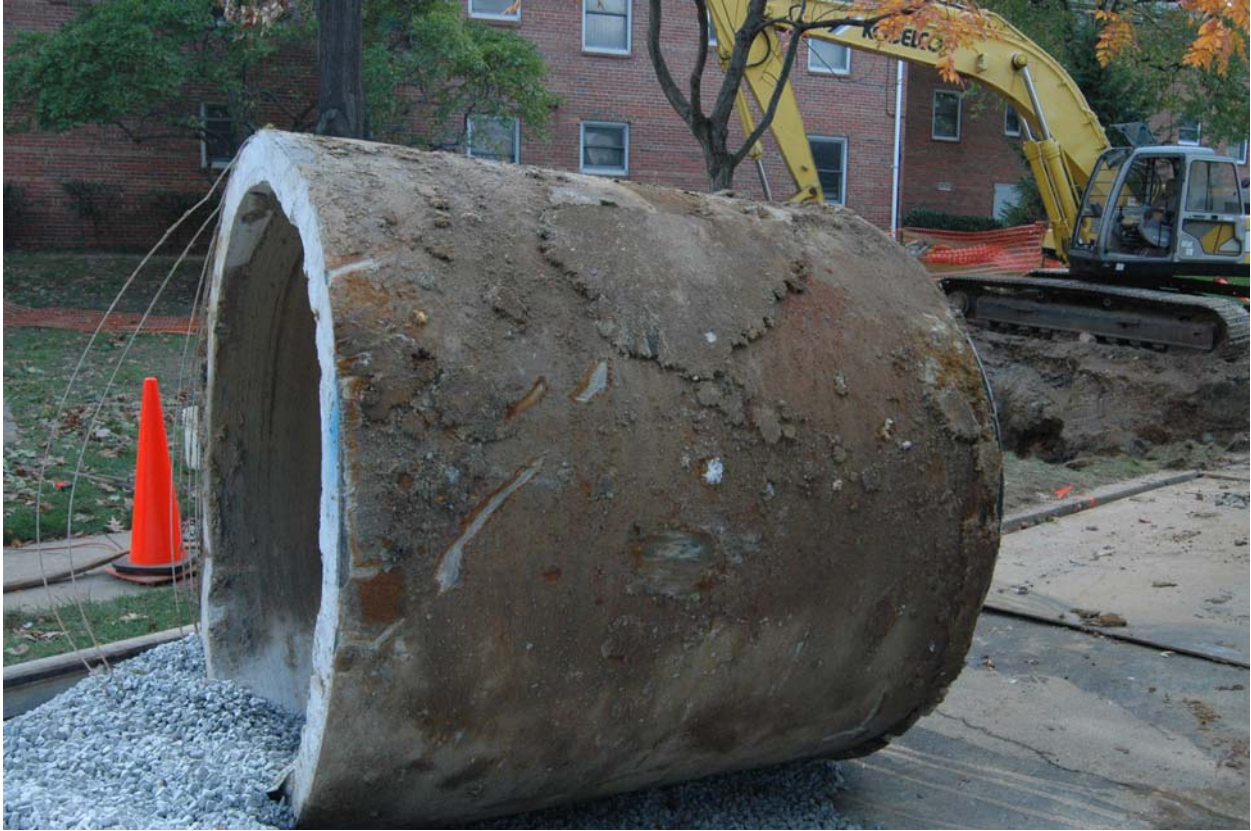
The spigot portion of the pipe was observed and there were no readily visible signs of distress in this portion of the pipe. This length of pipe section measured approximately 5'-10" long.

Spigot Portion of the pipe. No damage was observed on this portion of the pipe.

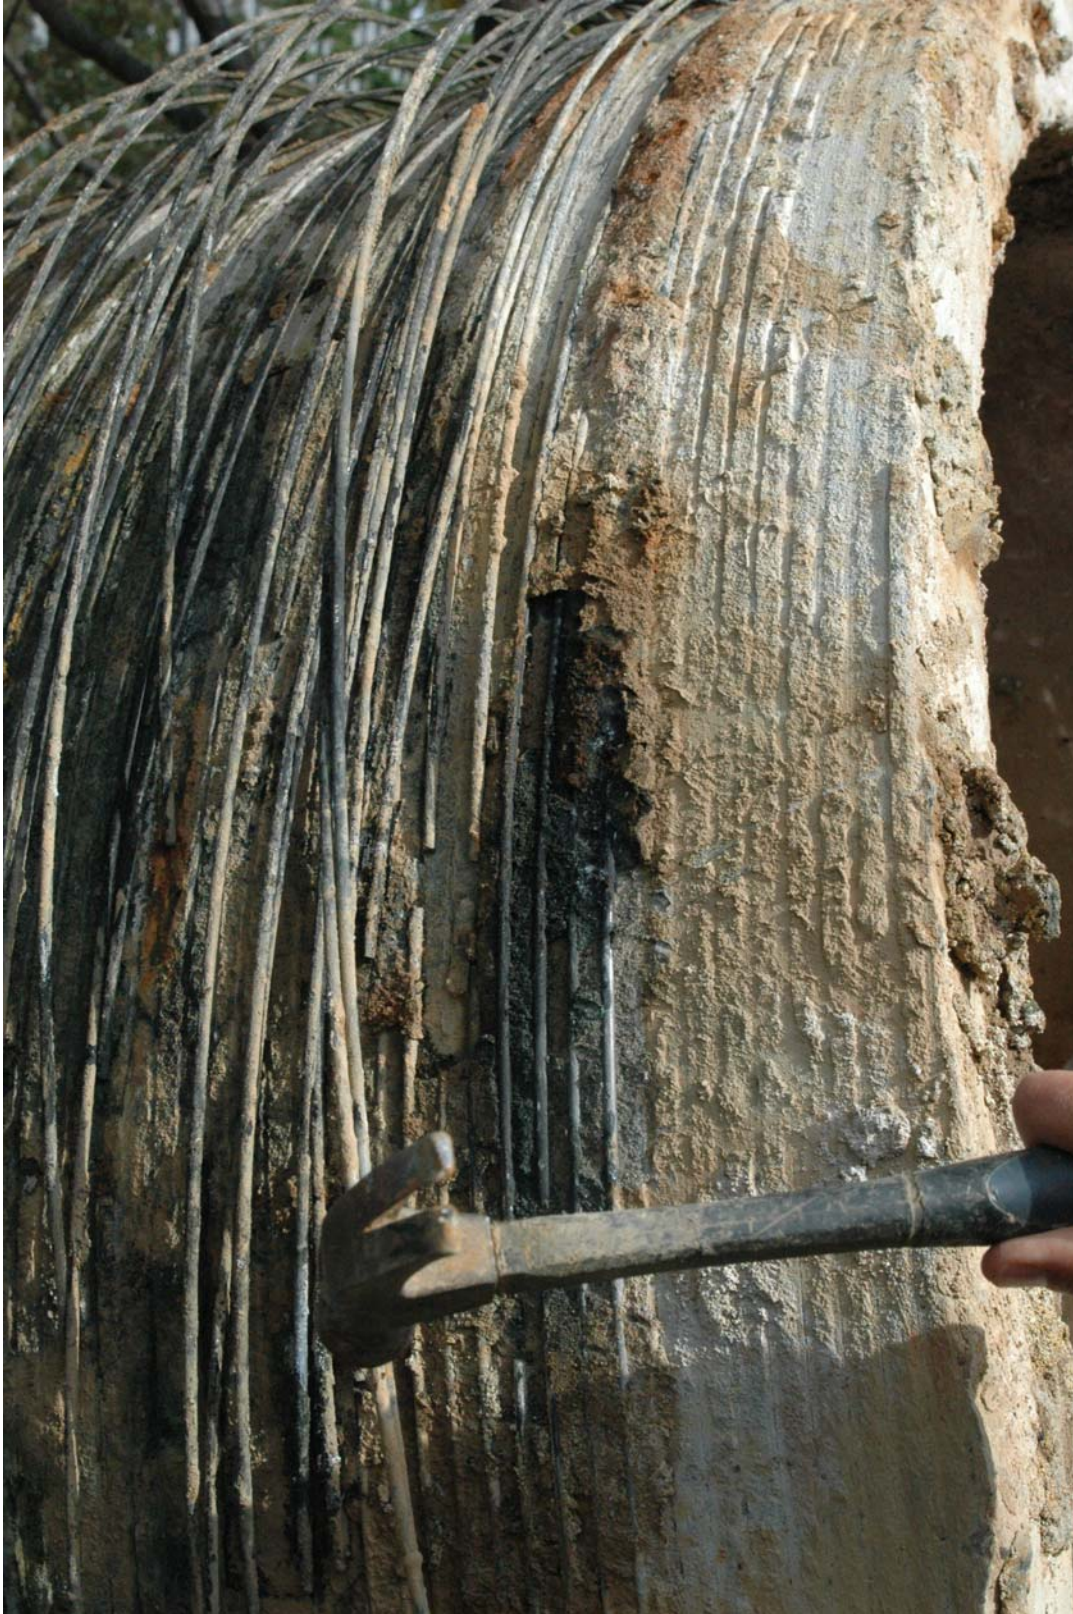
Close up of some of the wire break damage. The wires had a black film on them. Significant quantities of rust were not observed.

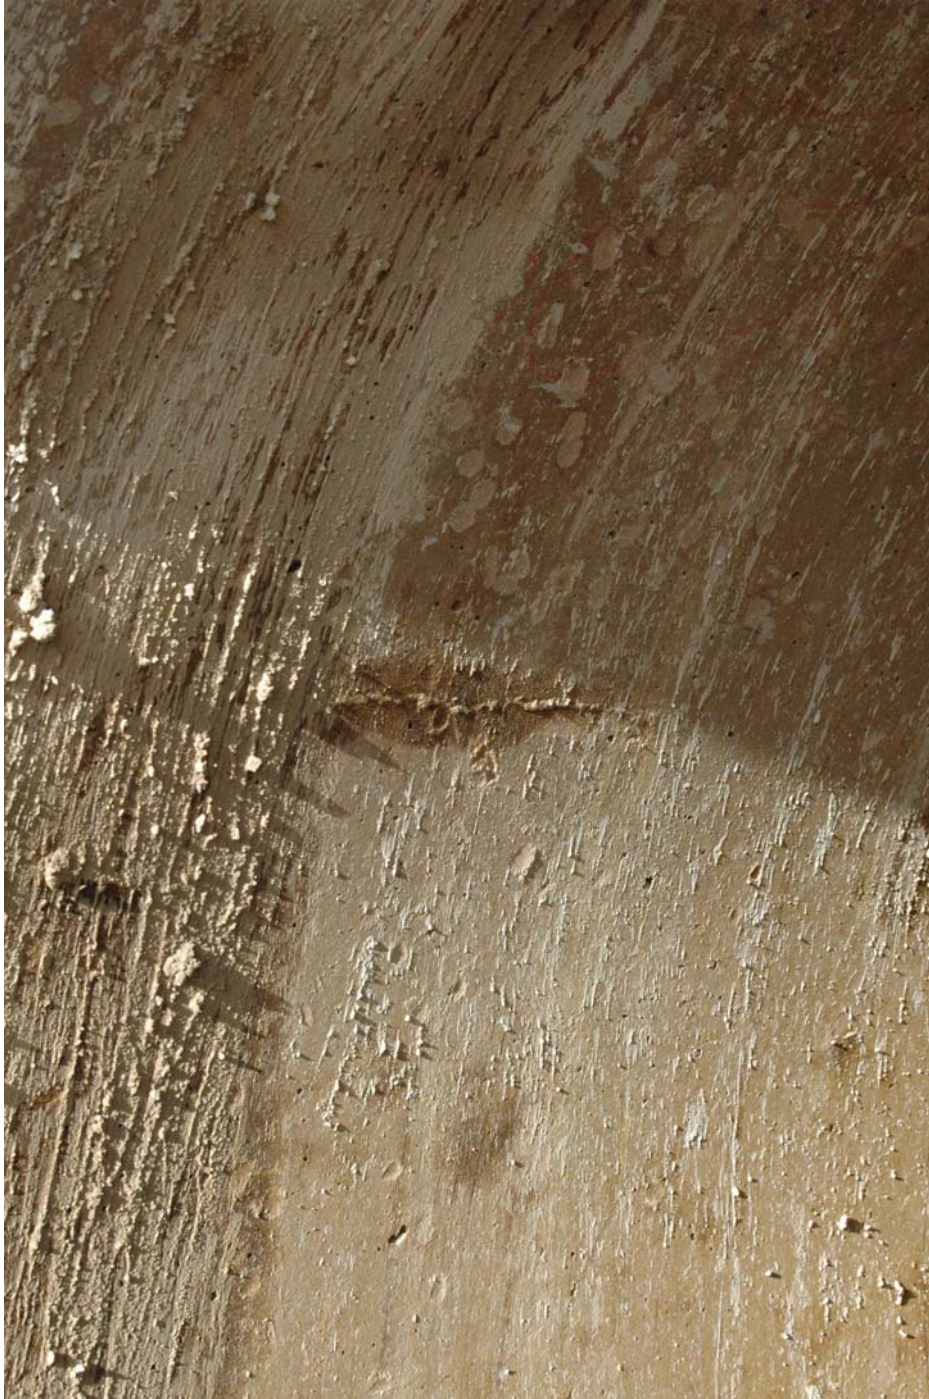
Crack on interior of the pipe at the location of the wire break damage, along springline. Other cracks in the pipe could not be observed due to the presence of debris and silt in the pipe.

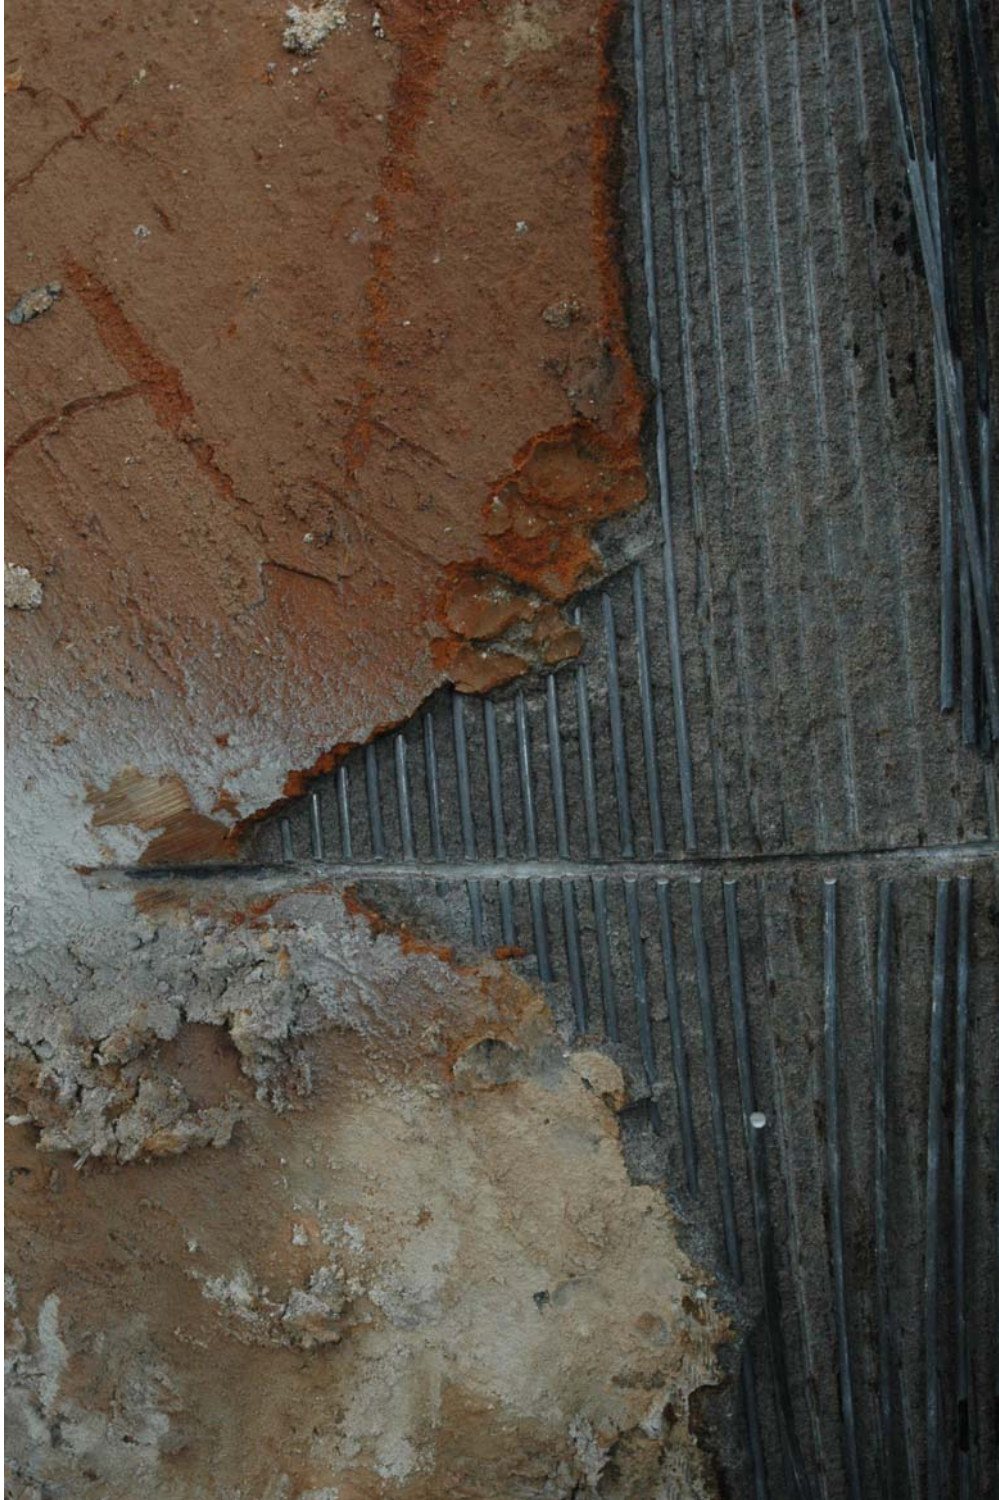
To verify the wire breaks zone, a saw was used to cut through the prestressing wire on the bell portion of the pipe to see if wire break damage extended further. However, no wire breaks were identified based on this work and it appeared that the wire break damage was limited to the area defined above.

A saw was used to cut additional wires to facilitate mortar removal and to confirm that corrosion damage did not extend further than what was observed. The wires in this region appeared in good condition and no wire breaks were observed.

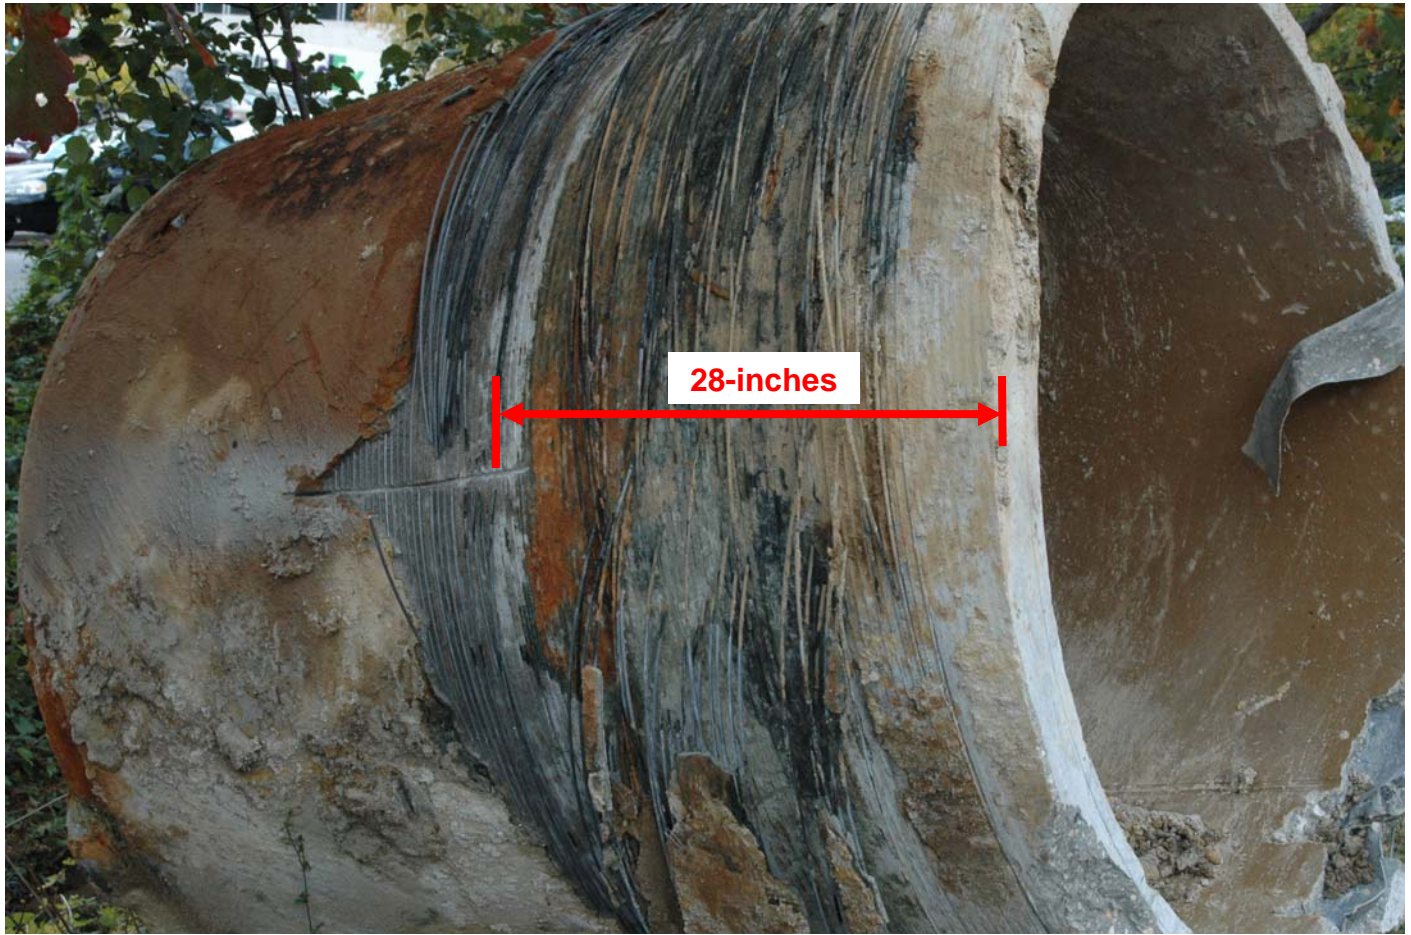
The number of wires in one foot length of pipe were counted and determined to be 23 wraps per foot. This is consistent with the lay schedule that indicates that the design provided 22.83 wraps per foot. Given the length of damaged wire and the wraps per foot, the estimated total number of wire breaks is 57 (30-inches of damage x 22.83 wraps per foot/12). It should be pointed out that this estimate of wire breaks assumes that all wraps were broken (which appeared to be the case). Further, it assumes that the contractor's estimate of length of damage into the middle section was correct at a couple of inches. WSSC personnel (Mike Woodcock) manually counted 52 wire breaks, but it is possible that a few wire breaks were not found due to the difficulty of manually counting wires and the fact that the middle portion of the pipe was not present. In any case, the actual number of wire breaks should be in the vicinity of 57 wire breaks.

The wire break damage for the pipe extended over 28 inches. The contractor indicated that the damage extended further (to the right in this photo) by a couple of inches. This portion of the pipe had been hauled away and thus could not be inspected. Thus the total length of wire break damage was approximately 30-inches.

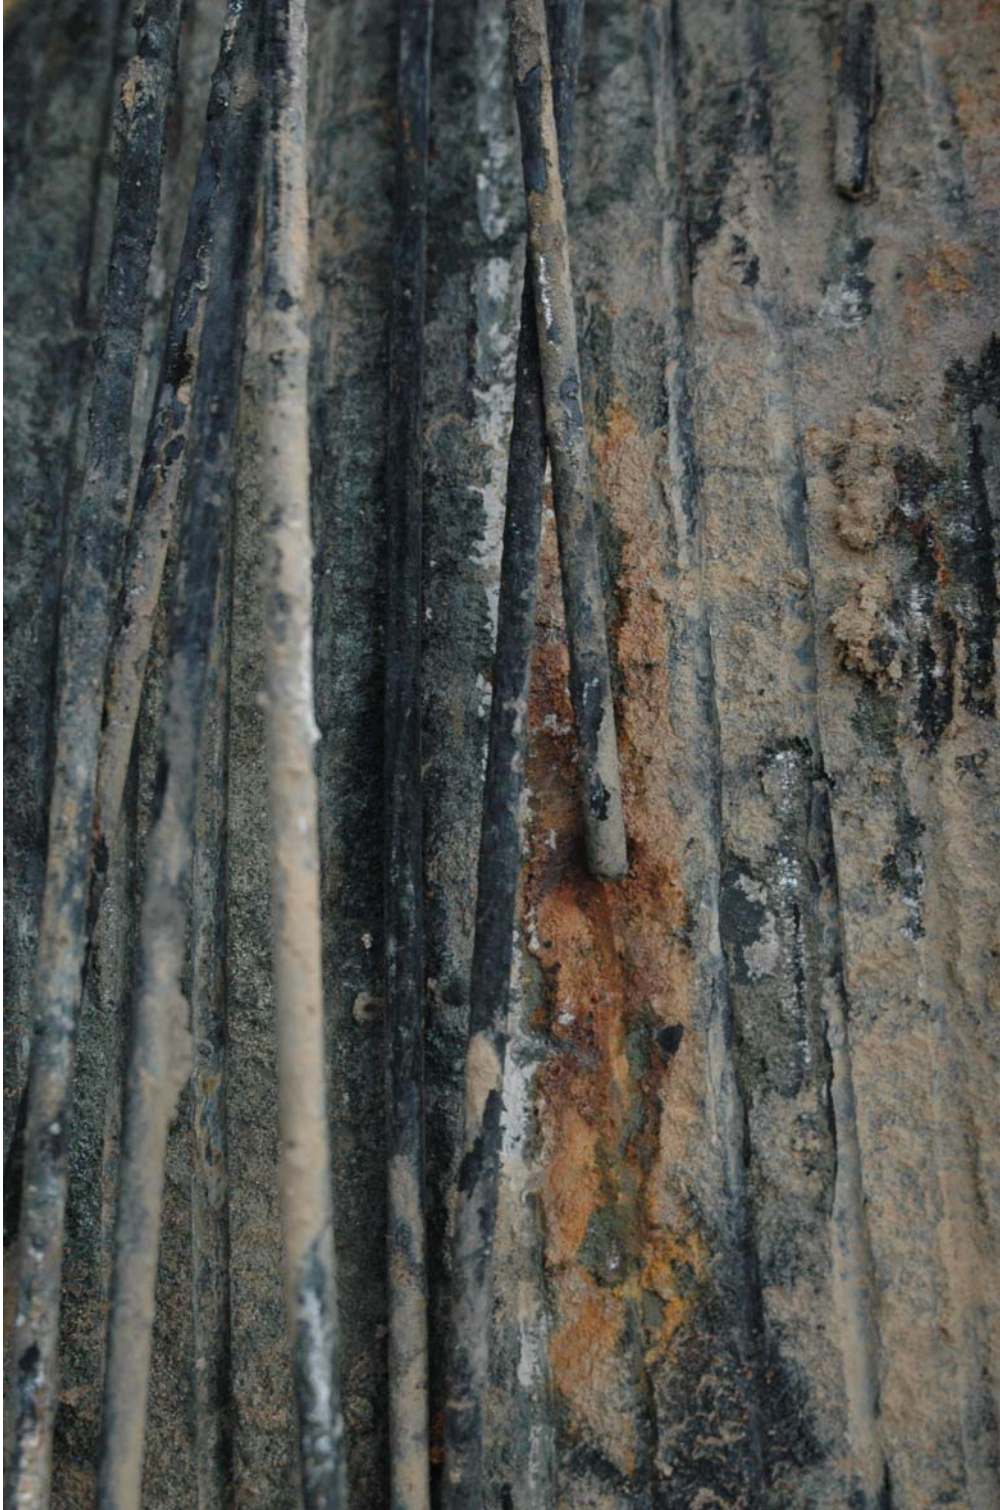
Close up of wire breaks.

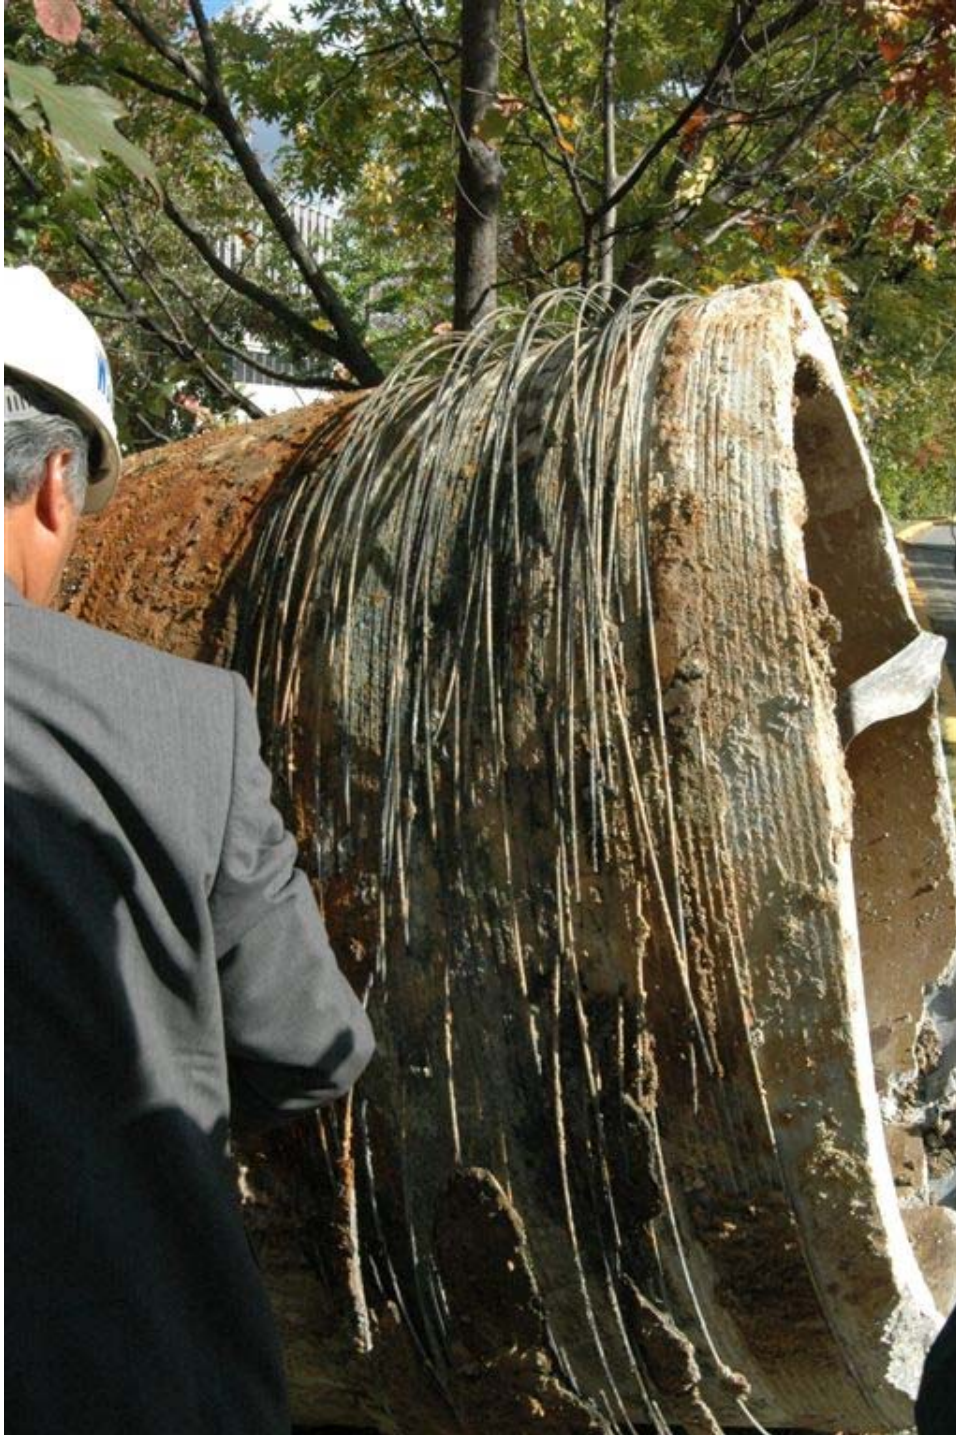
Wire Break Damage on the bell portion of the pipe section.

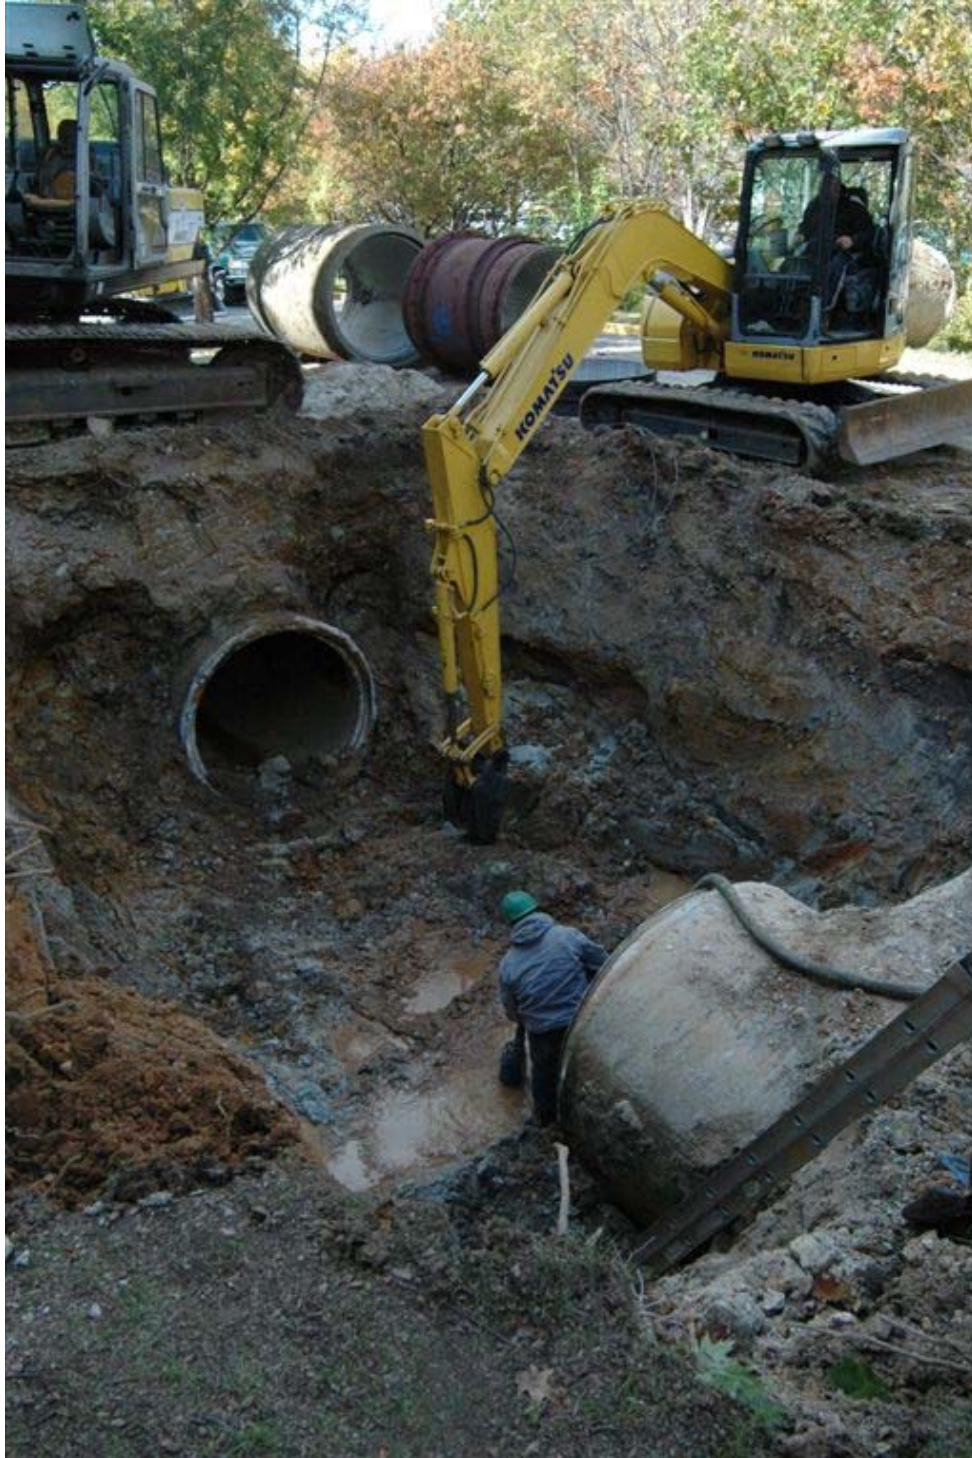
Photograph of the excavation. The pipe at the top of the photo is G295. It was confirmed that G295 was next to an air release valve, which is consistent with the inspection records. Thus the correct pipe was excavated.

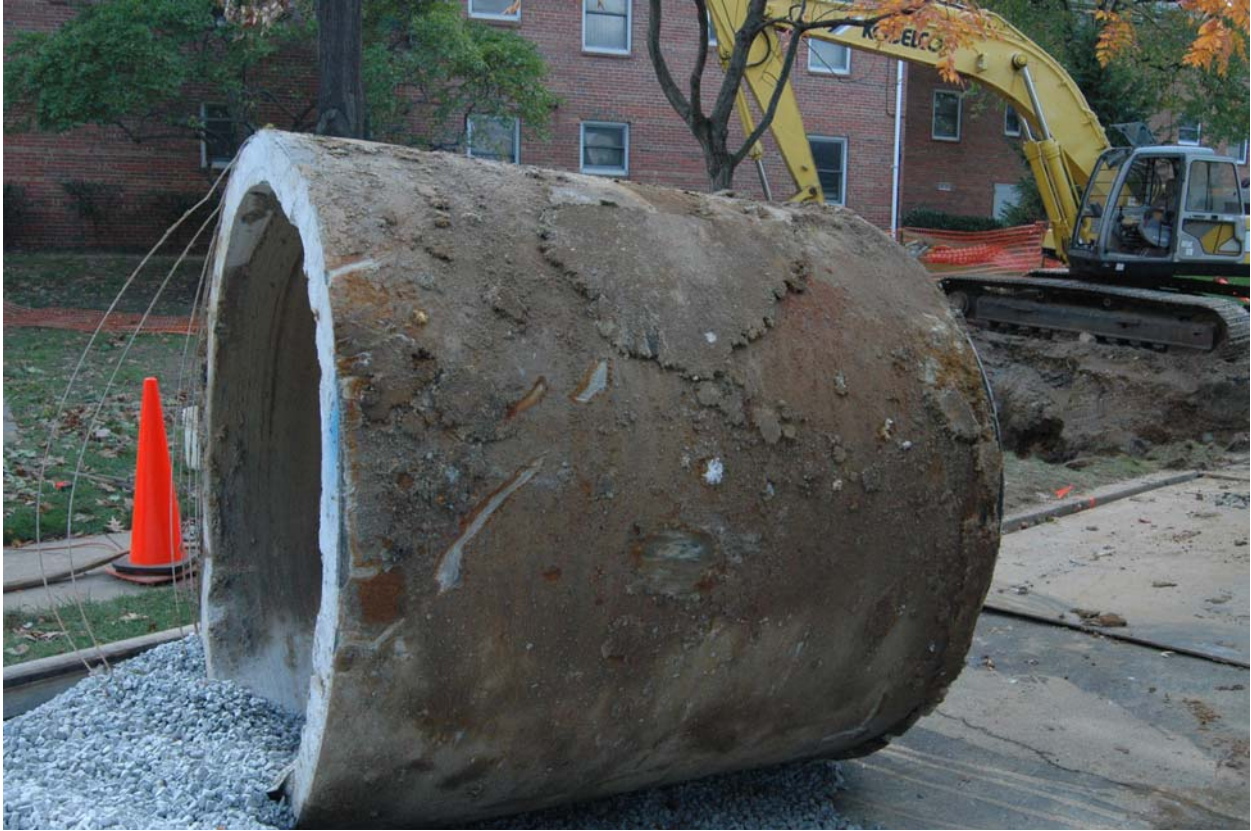
Spigot Portion of the pipe. No damage was observed on this portion of the pipe.

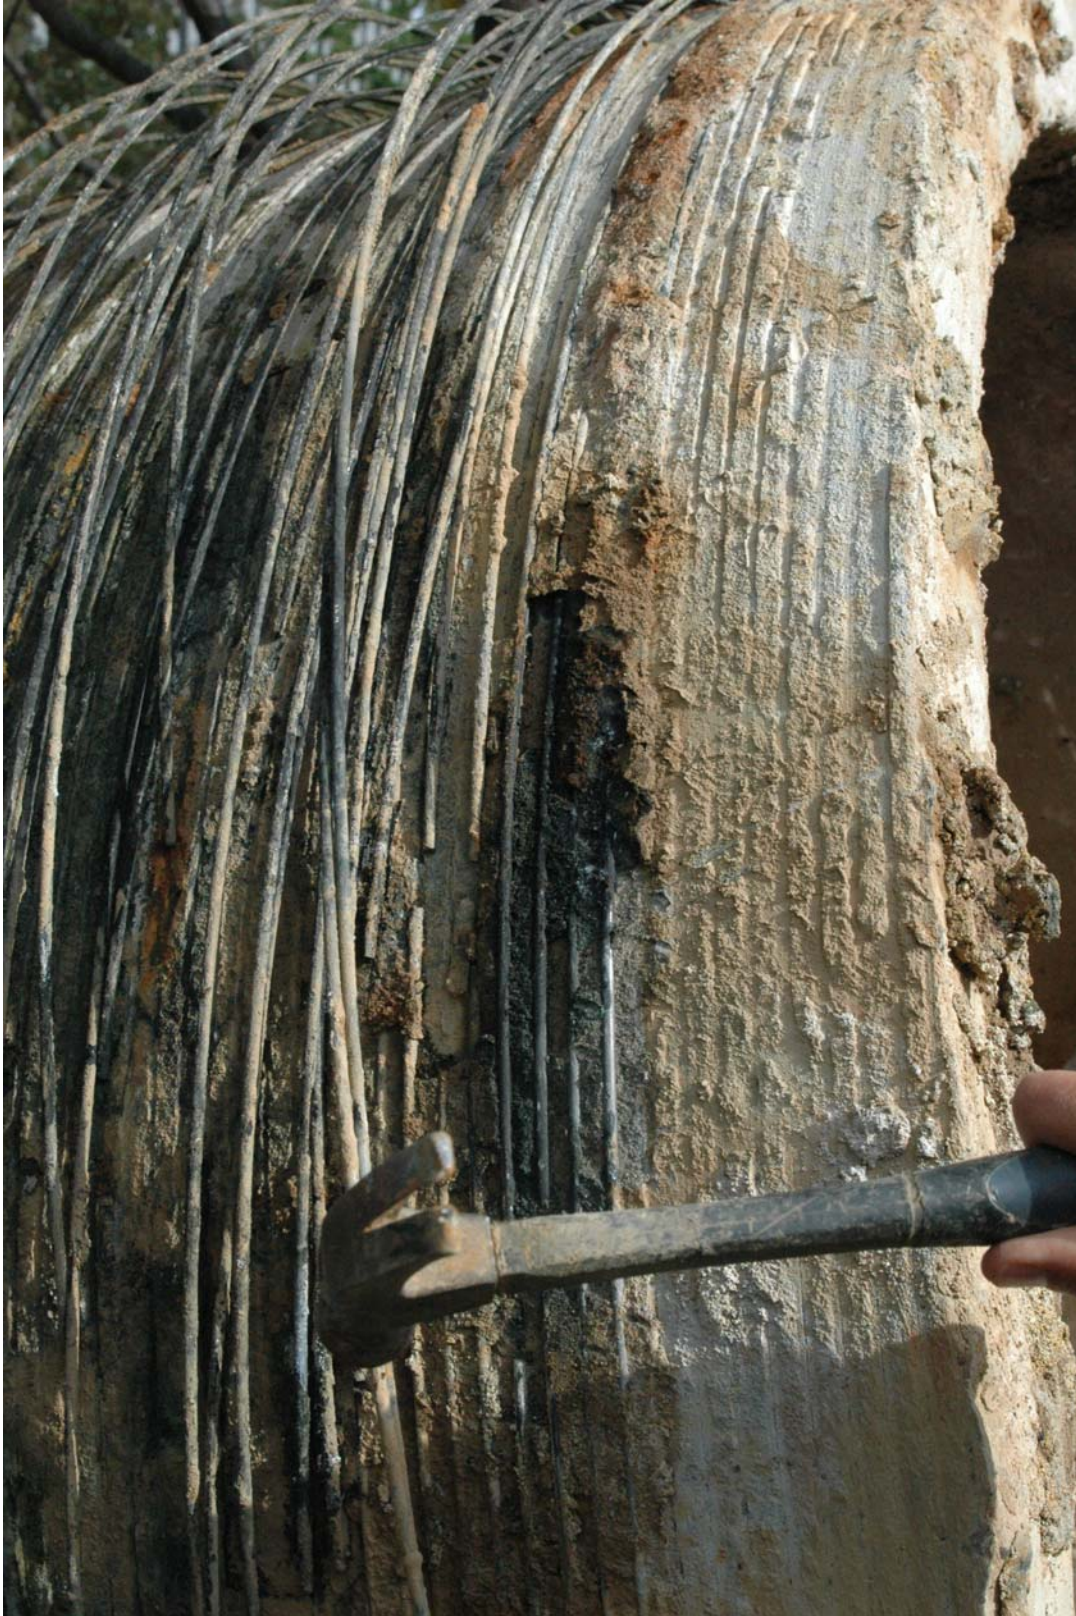
Close up of some of the wire break damage. The wires had a black film on them. Significant quantities of rust were not observed.

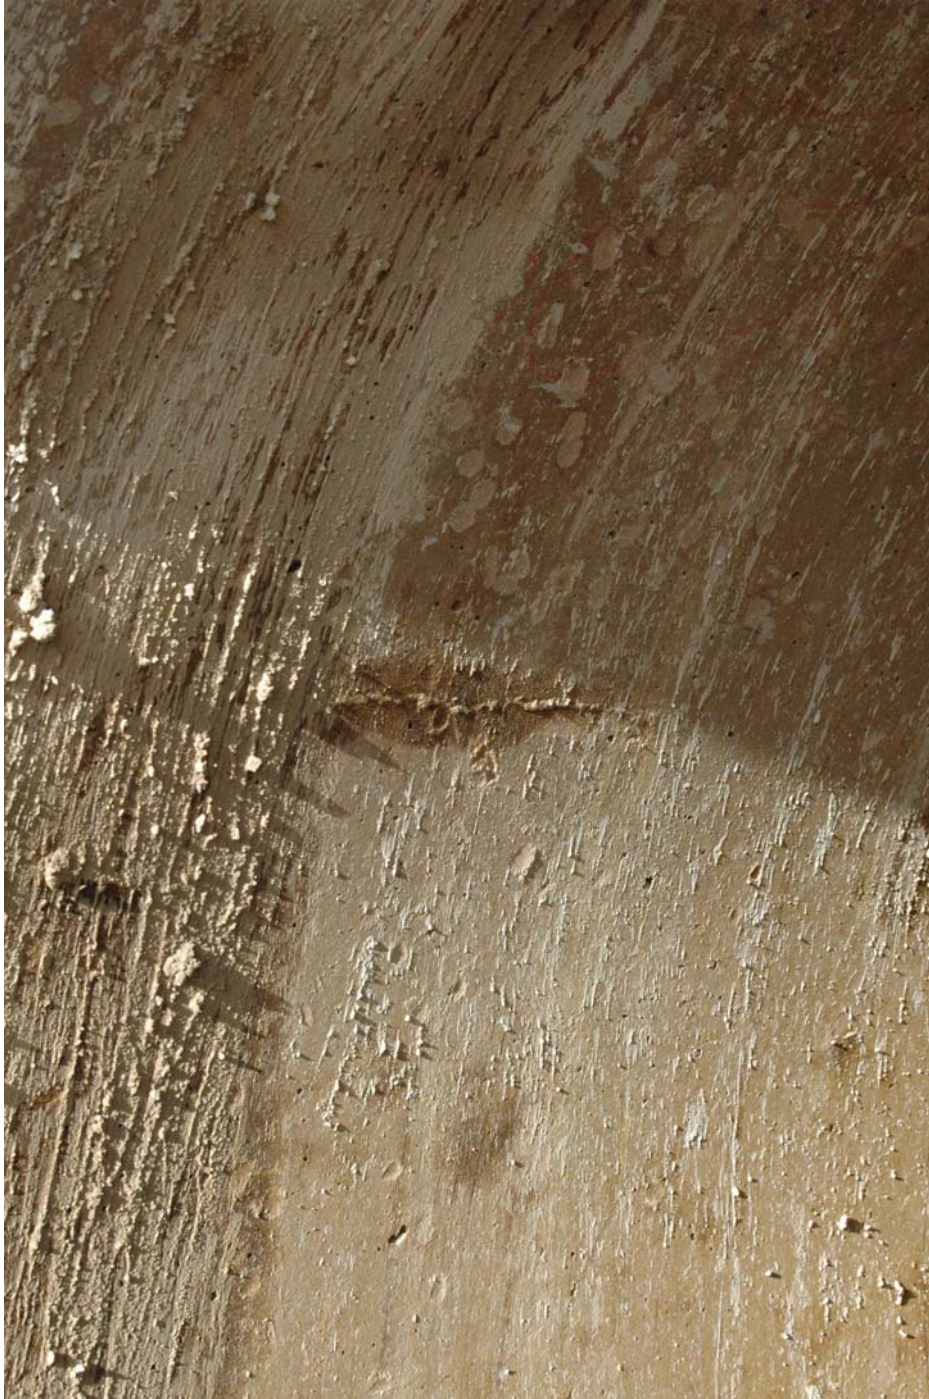
Crack on interior of the pipe at the location of the wire break damage, along springline. Other cracks in the pipe could not be observed due to the presence of debris and silt in the pipe.

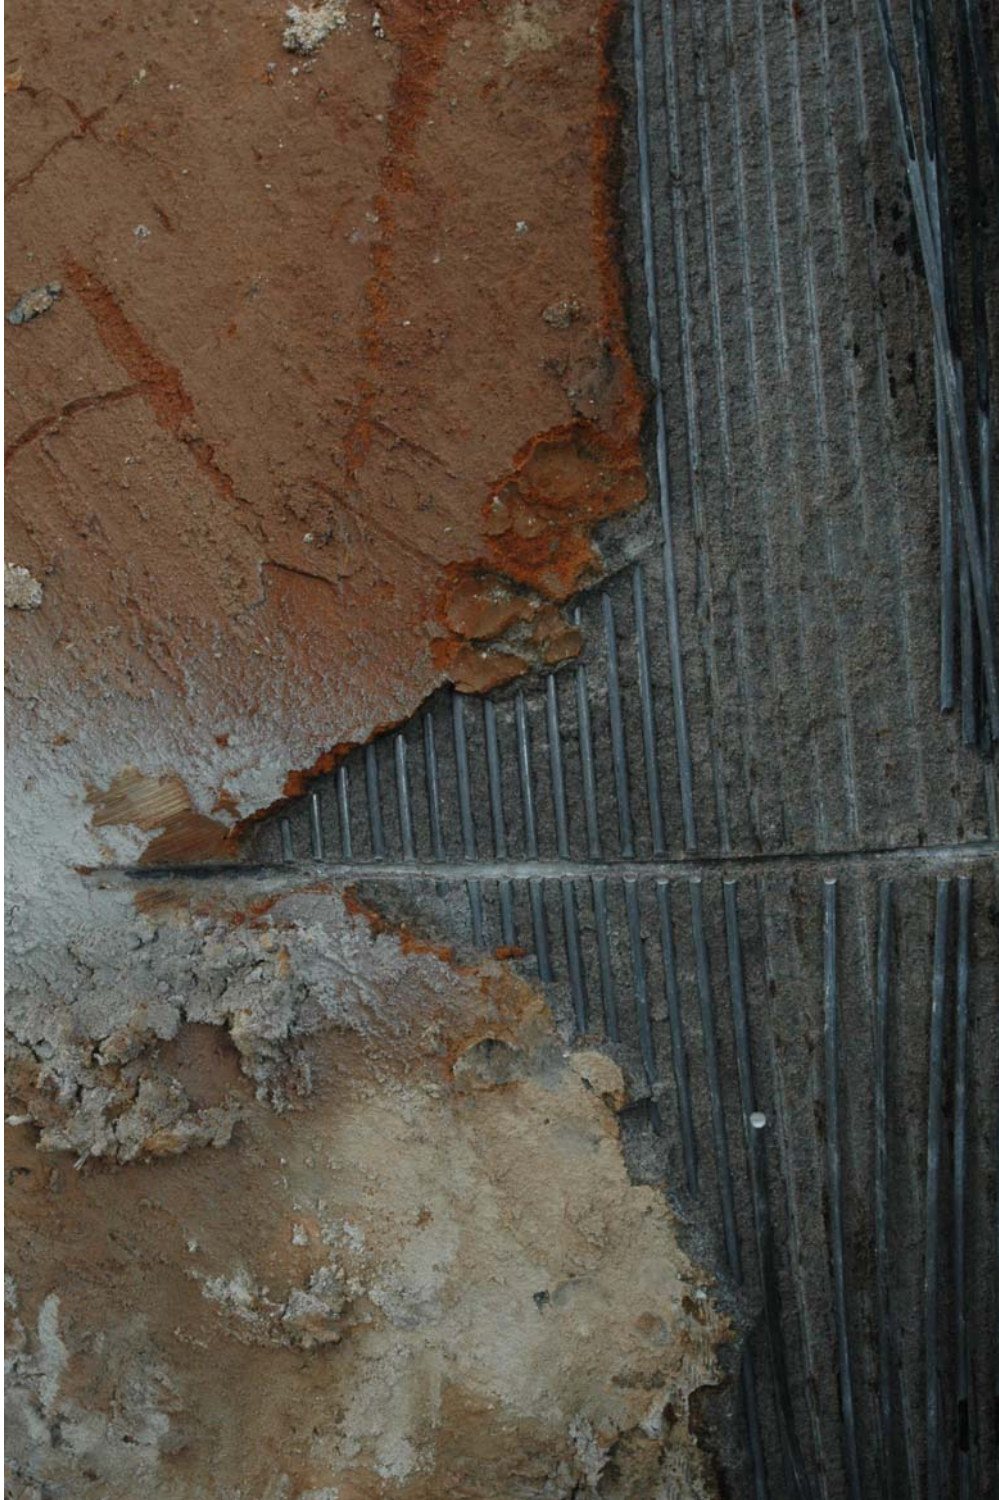
A saw was used to cut additional wires to facilitate mortar removal and to confirm that corrosion damage did not extend further than what was observed. The wires in this region appeared in good condition and no wire breaks were observed.

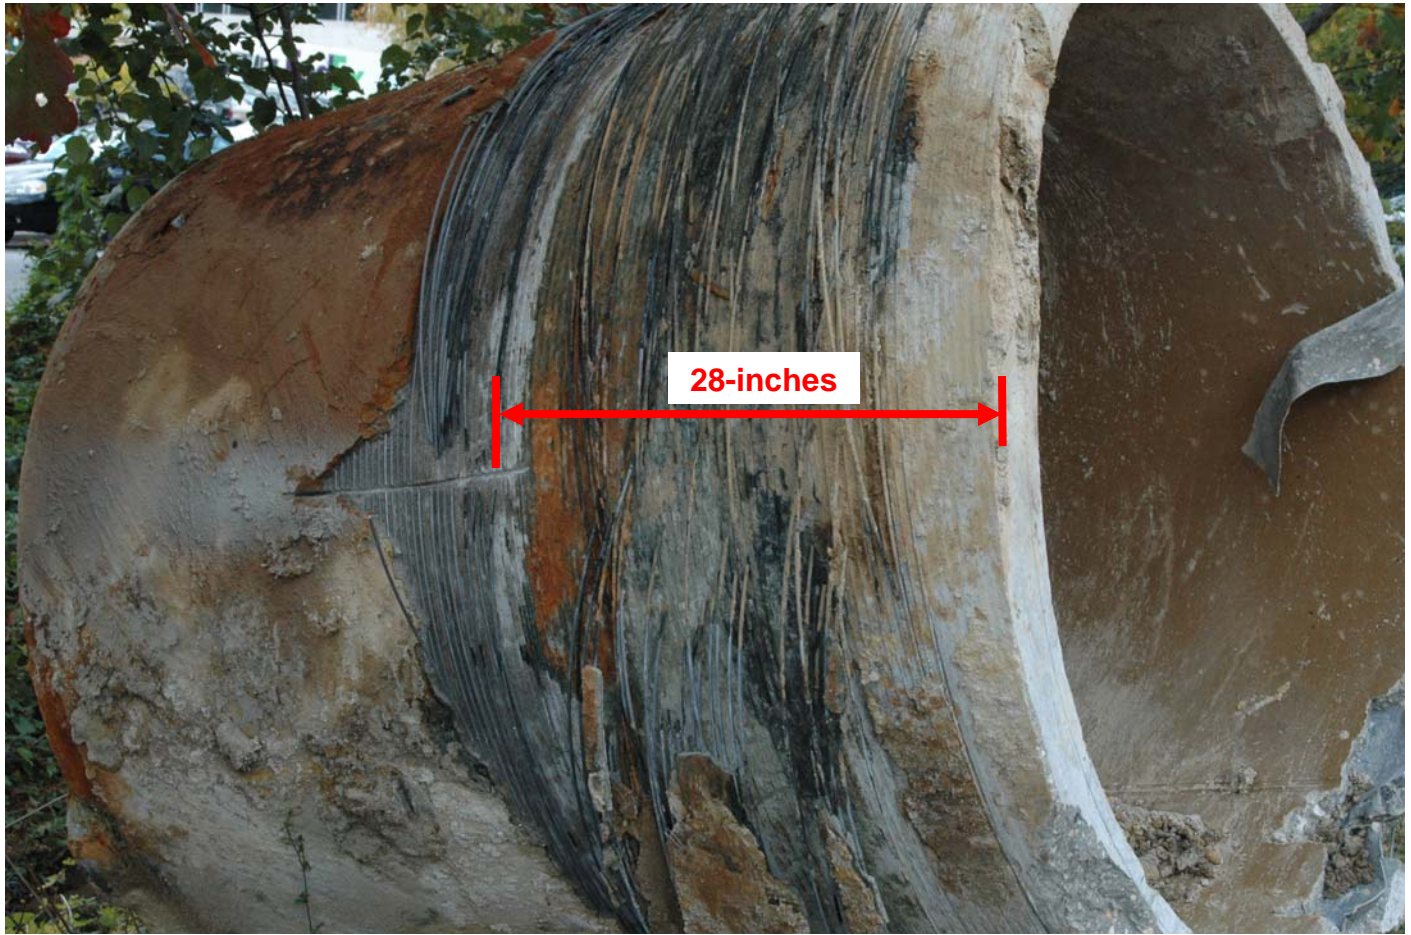
The wire break damage for the pipe extended over 28 inches. The contractor indicated that the damage extended further (to the right in this photo) by a couple of inches. This portion of the pipe had been hauled away and thus could not be inspected. Thus the total length of wire break damage was approximately 30-inches.
