**MICHAEL S. HIGGINS TECHNICAL MEMORANDUM – PIPE G296**

SUBJECT: Excavation of Pipe Section G296

**MICHAEL S. HIGGINS TECHNICAL MEMORANDUM – PIPE B217**

SUBJECT: Excavation of Pipe Section B217

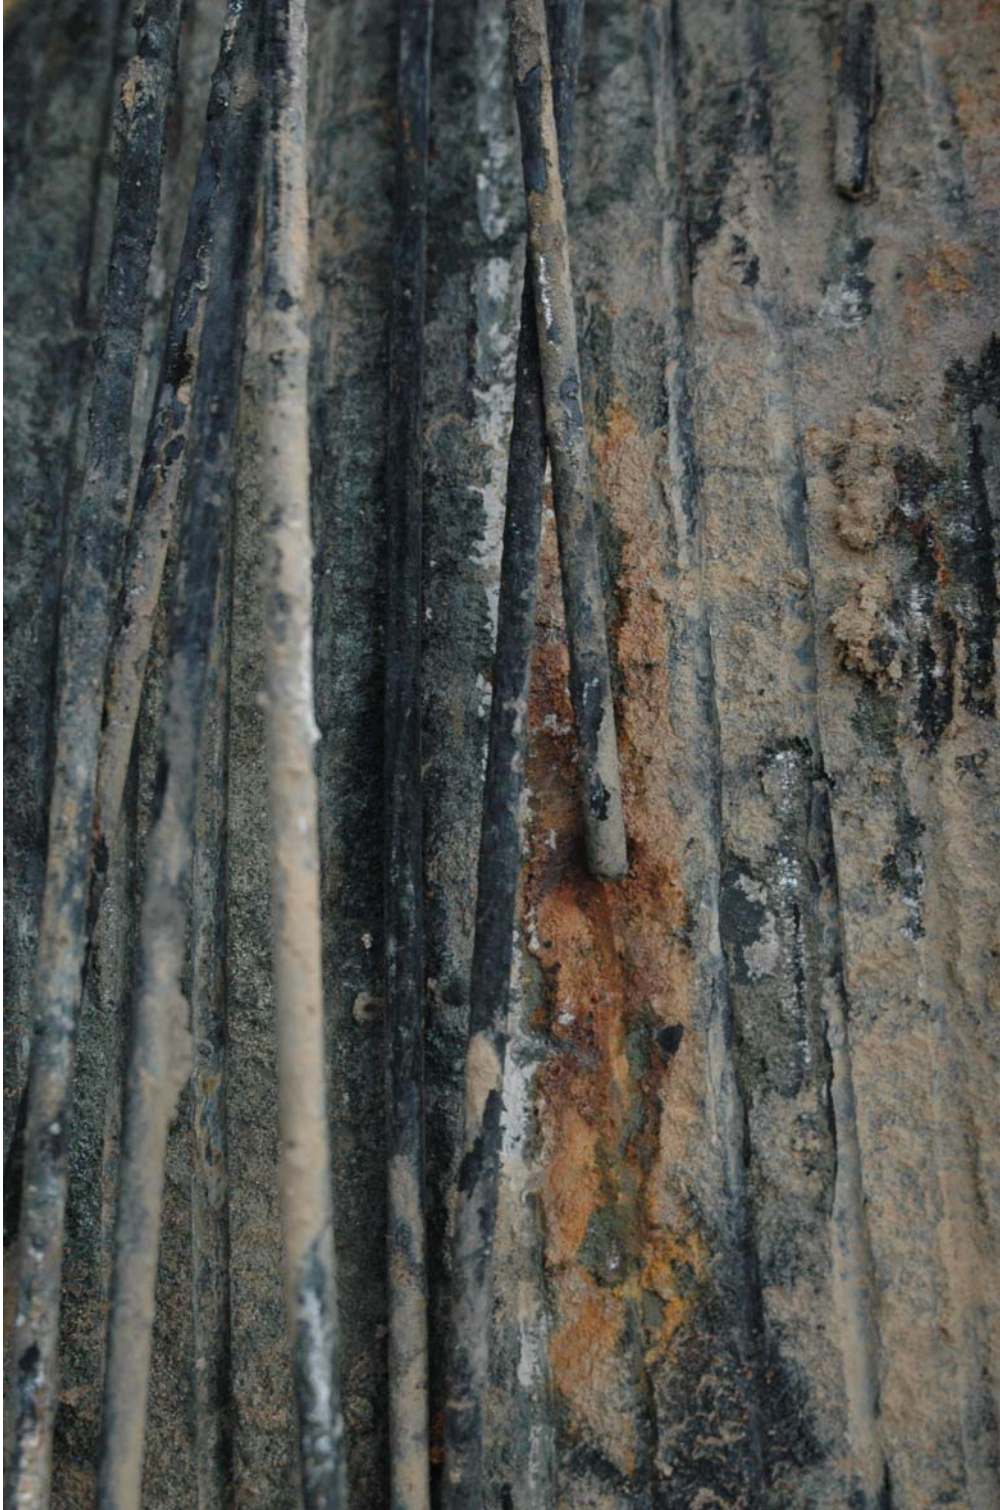
Close up of wire breaks.

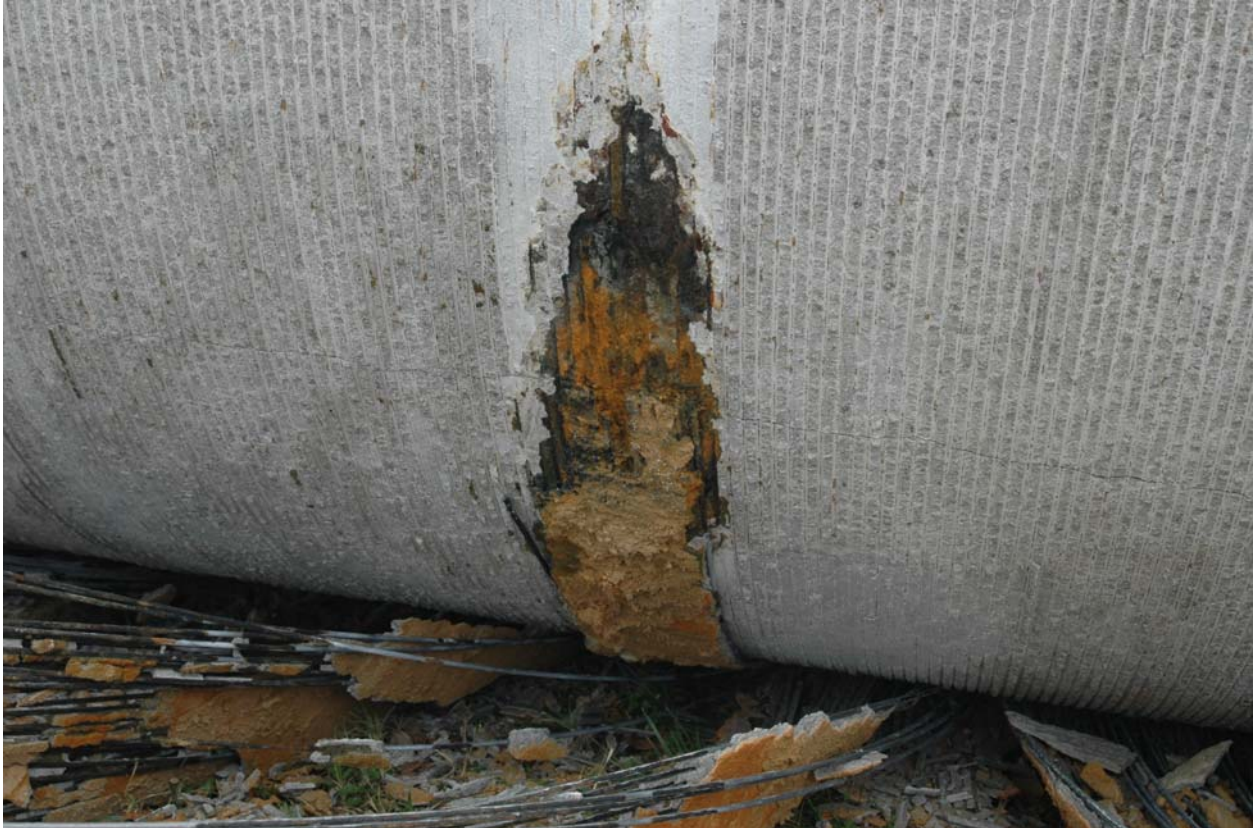
Once all the mortar coating was removed, on large area of corrosion was observed on the prestressing wire. The corroded area started at approximately 7 feet from the spigot and continued to at least the end of the pipe still intact (to the point where the pipe had been sawcut). Thus there was a minimum length of approximately 5 feet with corrosion damage. The area of corrosion was on the invert of the pipe up to approximately the north springline. The wire appeared black in this area.

Corrosion product on concrete core at the location of wire break zone 1.

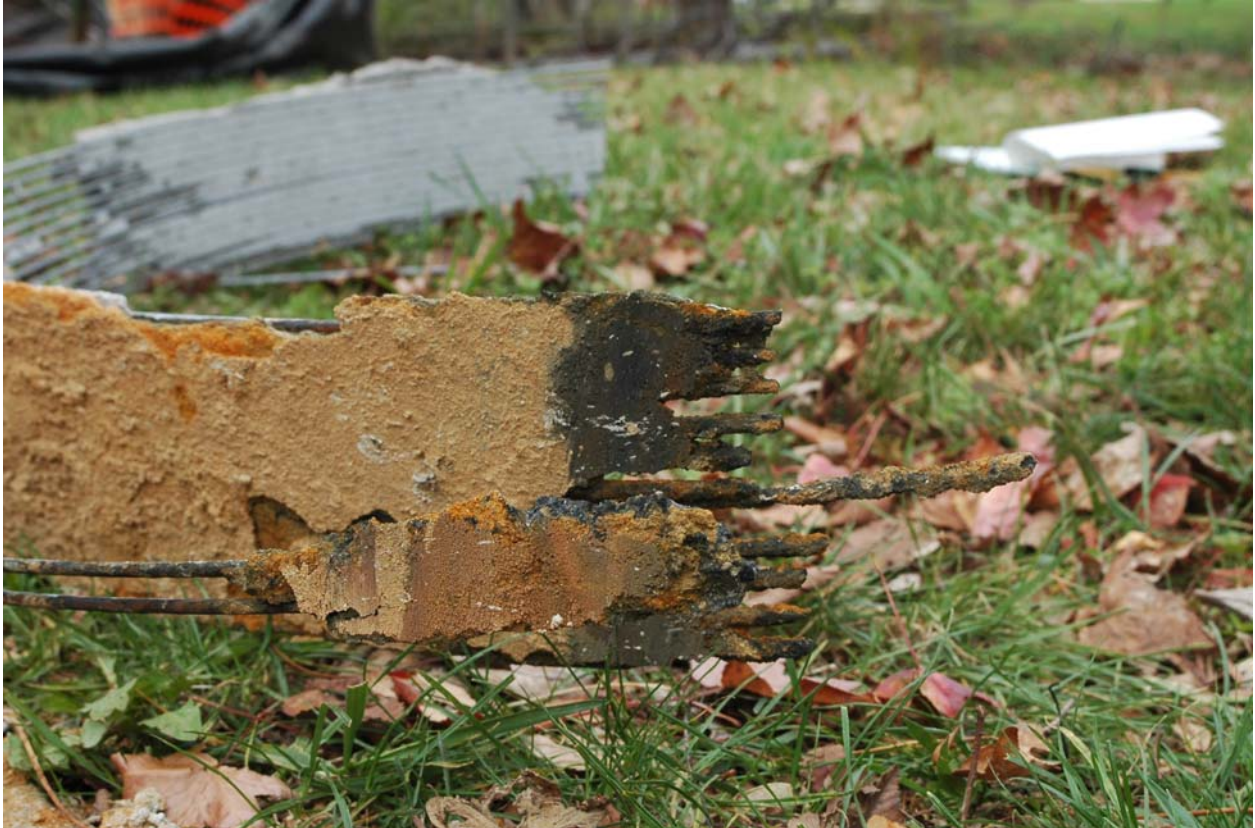
- First wire break zone: The first area of wire breaks consisted of 16 wire breaks. The breaks were concentrated in a length approximately 8". The zone was centered approximately 7.5 feet from the spigot.
- Second wire break zone: The second area of wire breaks consisted of 5 to 10 wire breaks over approximately 3 inches. The exact number could not be ascertained as the location of the breaks was on the bottom of the pipe as it was sitting on the ground. This wire break zone was located at approximately 9' from the spigot.

Group of wire breaks that were removed from wire break zone 1. Photo shows 12 wire breaks (some wires are not clearly visible). There was a total of 16 wire breaks in this zone.

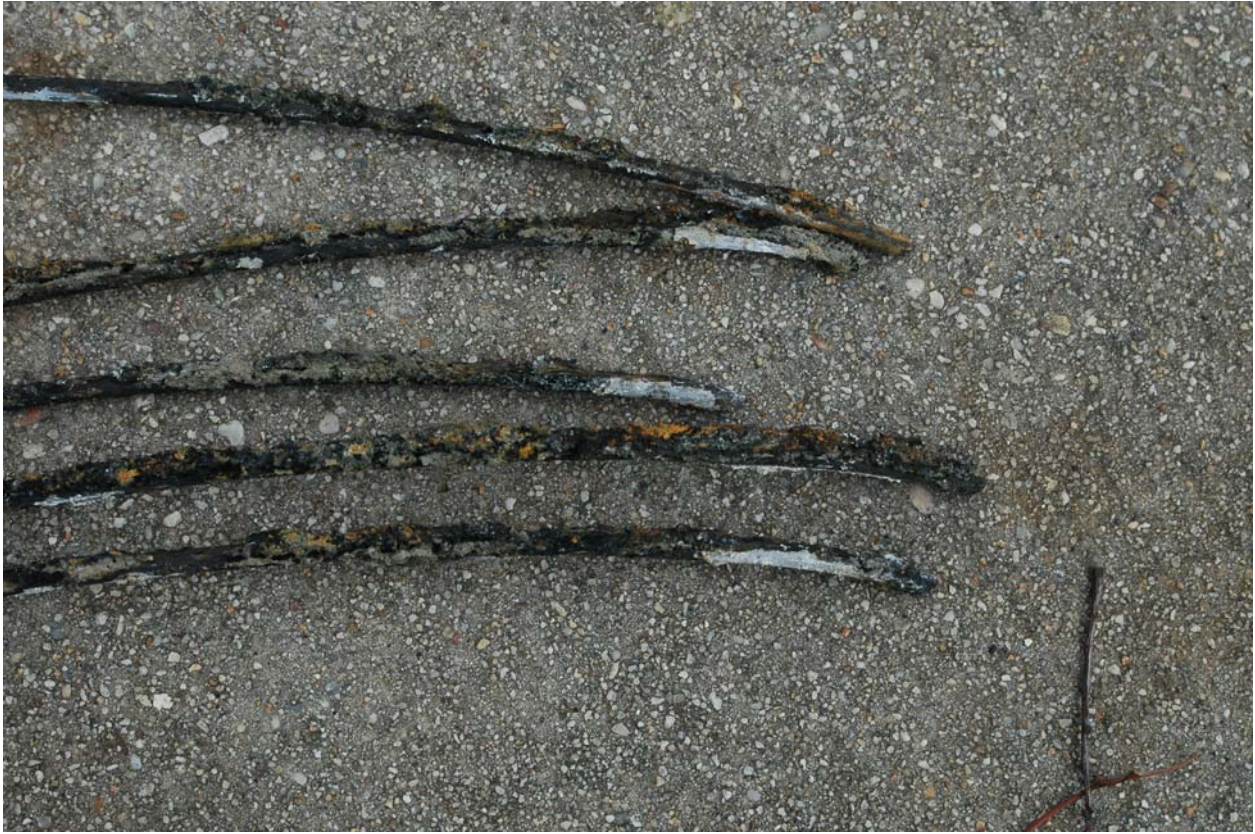
Five wire breaks taken from wire break zone 2. There were between 5 and 10 wire breaks in this zone.

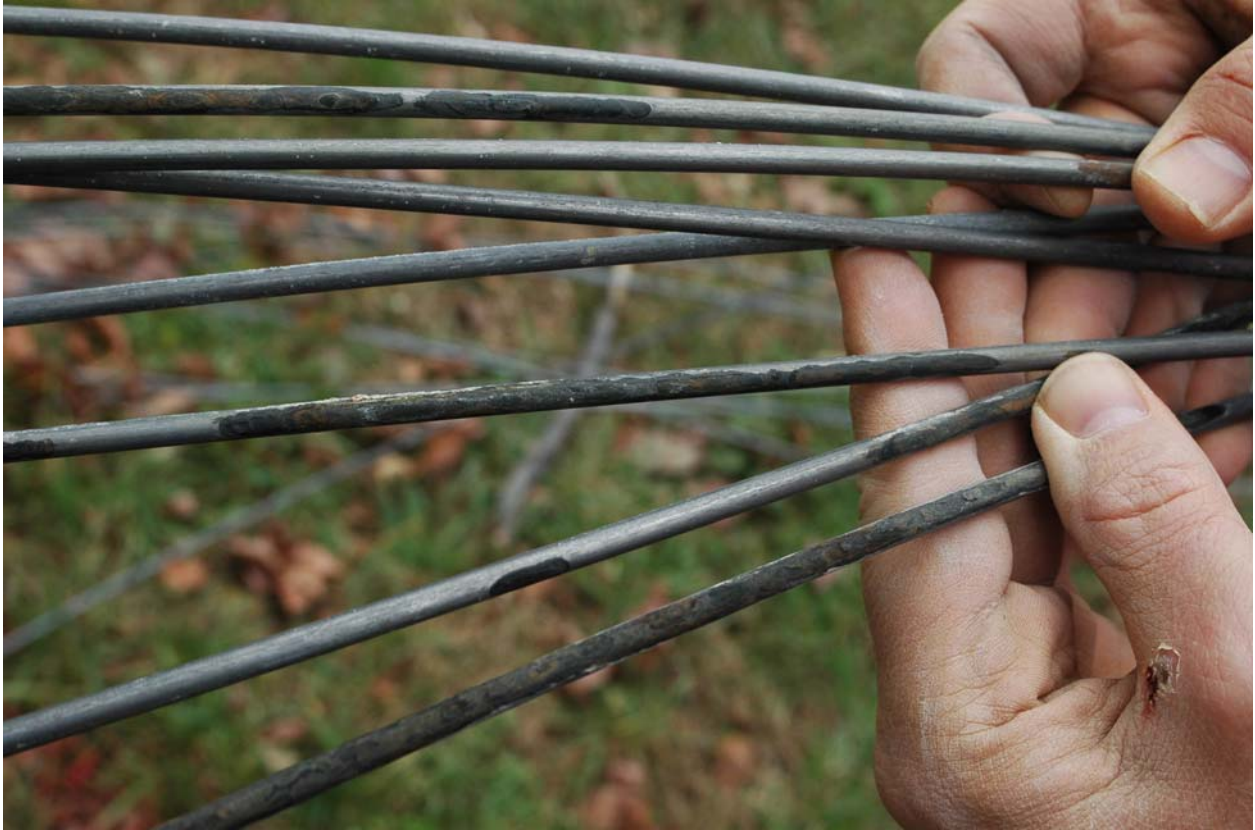
Close up of corrosion product found on all wires in the area of corrosion. The corrosion area was at least 5 feet long. In this region all wires exhibited this type of corrosion product.

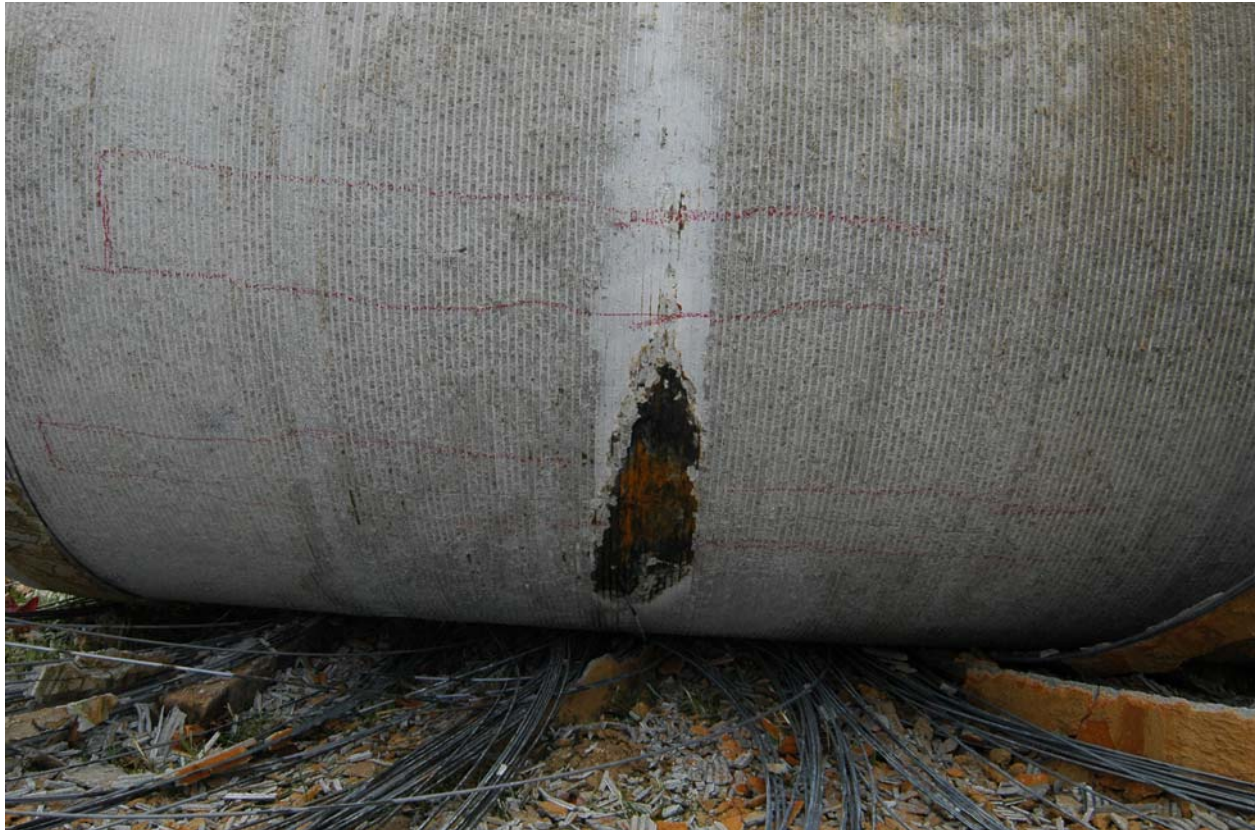
It should also be noted that there was a crack in the concrete core at the location of the corrosion zone and wire break damage. It was not possible to determine if this crack was present when the pipe was in the ground or developed as a result of the forensic work.

Two cracks in the concrete core were observed at the location of the of wire break damage. It is unknown whether or not these cracks existing when the pipe was in the ground or result from the forensic work. The cracks are within the red outline. A closer view of the cracks can be observed in the photo on page 3.

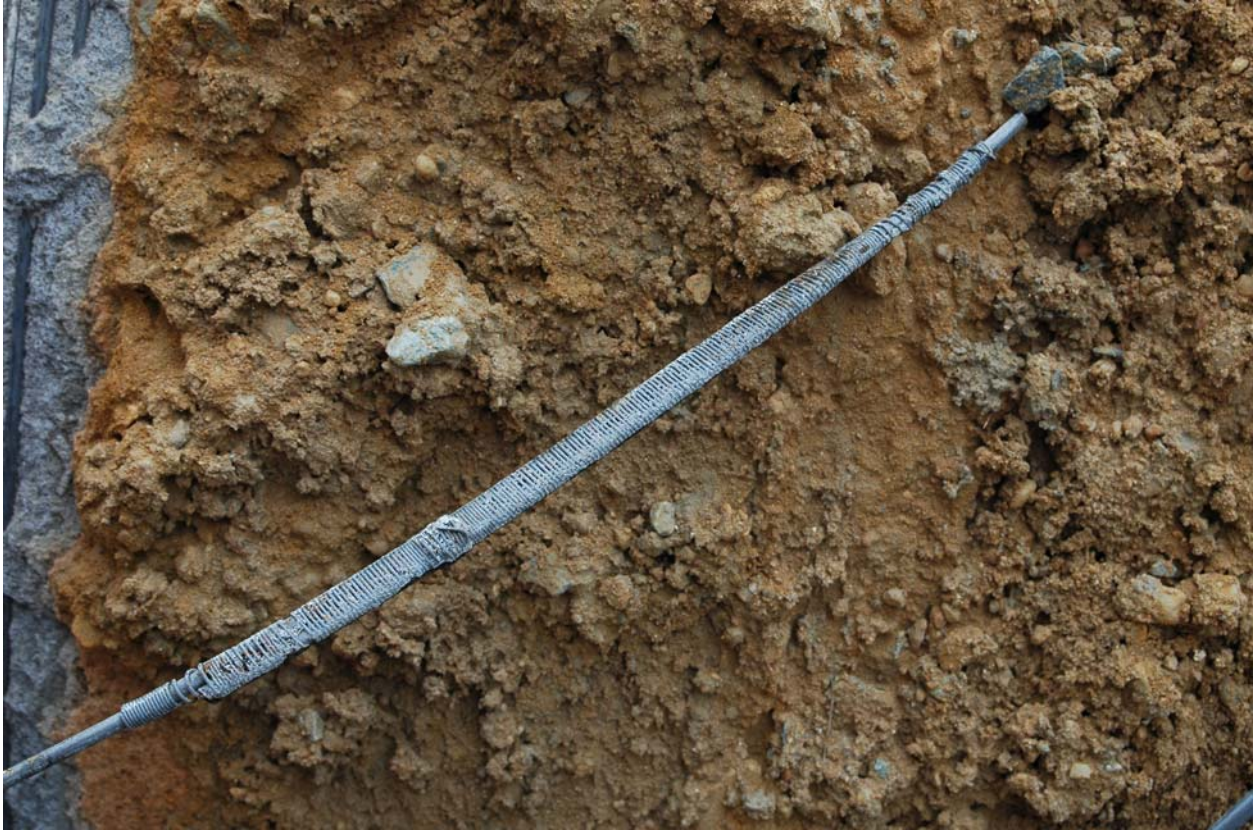
It should also be documented that there was a wire splice approximately 6 feet from the spigot end of the pipe. According to Mike Woodcock, the prestressing wires were not popping when they were being cut in this portion of the pipe. Thus, this portion of the pipe may not have been prestressed. Wire samples were taken by Mr. Woodcock from both sides of the splice for laboratory testing.

A wire splice was located approximately 6 feet from the spigot.
