OPENAKA CORPORATION, INC.

RE: Internal Inspection, 4.7 Kilometers of 2.0 Meter Tibitó-Casablanca Pipeline
Openaka Project OP-9924E

The following letter report presents the procedures utilized and the results of the internal inspection of 4.7 kilometers of the 2.0 meter diameter prestressed concrete embedded cylinder pipe Tibitó-Casablanca transmission main conducted by Openaka Corporation on February 8 through February 10.

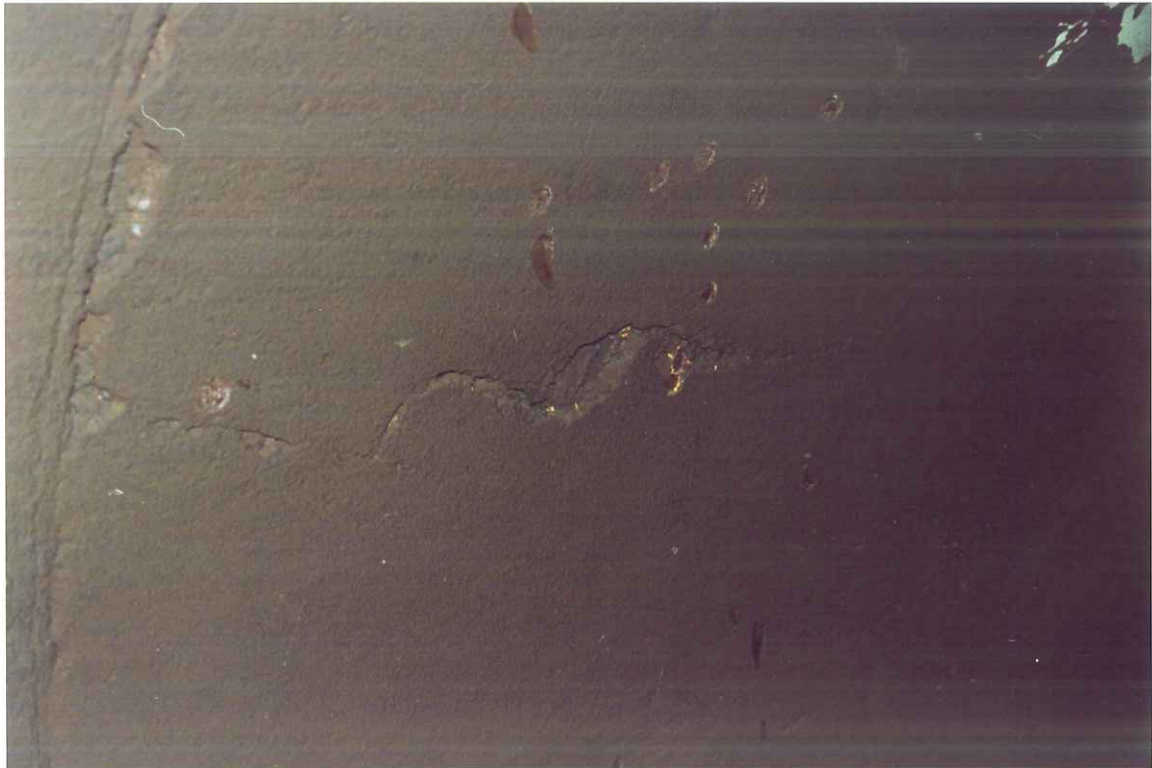
Cracking and spalling of the concrete lining of the steel plate special and reducer south of valve #7 at K0-290 was observed. There was a lining crack with some minor spalling at the west side of the reducer, Figure 1. Figure 2 is a photograph of the lining crack above the east springline. There was a large spall on the east side of the steel plate special, Figure 3.

Both fittings were noted to have hollow linings which are common in un-prestressed specials similar to steel pipes.

Figure 1. Cracked lining on the west side of the 2 meter by 1.5 meter reducer by valve #7, K0-260.

The large area of spalled concrete lining on the east side of the 2.0 meter steel plate special next to the reducer by Valve #7 at K0-290 should be repaired. The crack at the west side of the 2.0 meter by 1.5 meter reducer has some small spalled areas.

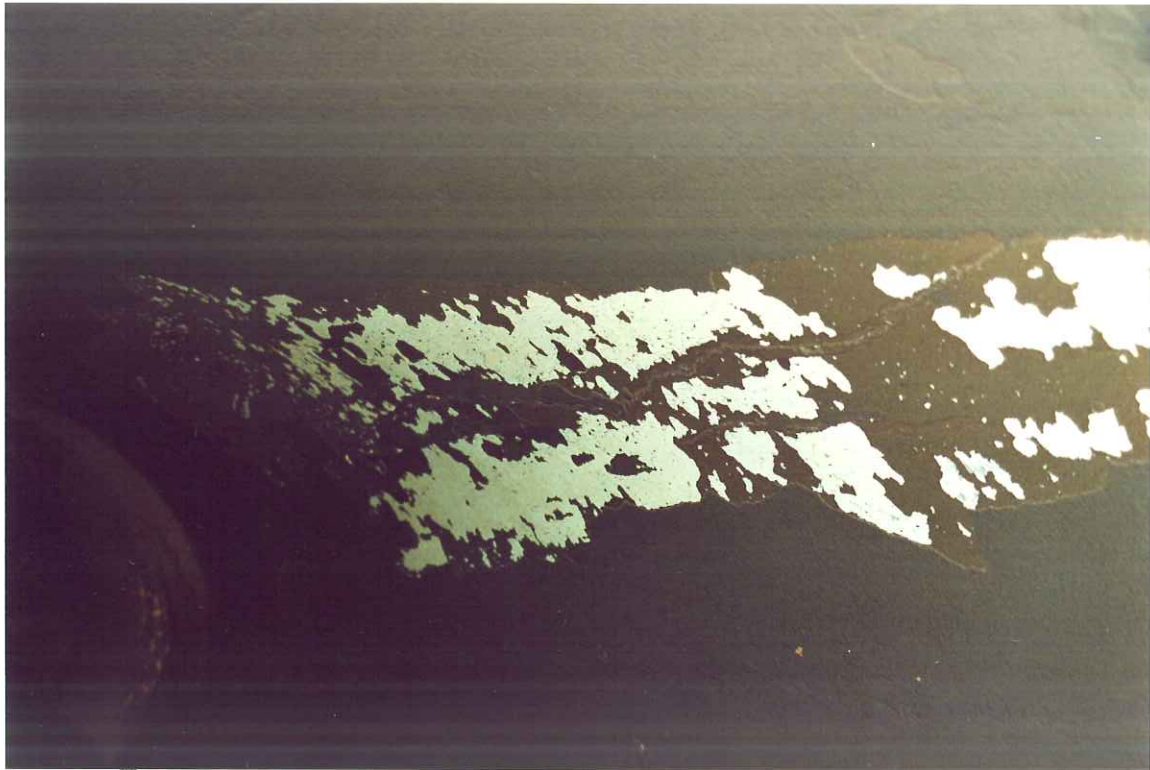
Figure 2. Cracked lining on the east side of the 2 meter by 1.5 meter reducer by valve #7, K0-260.

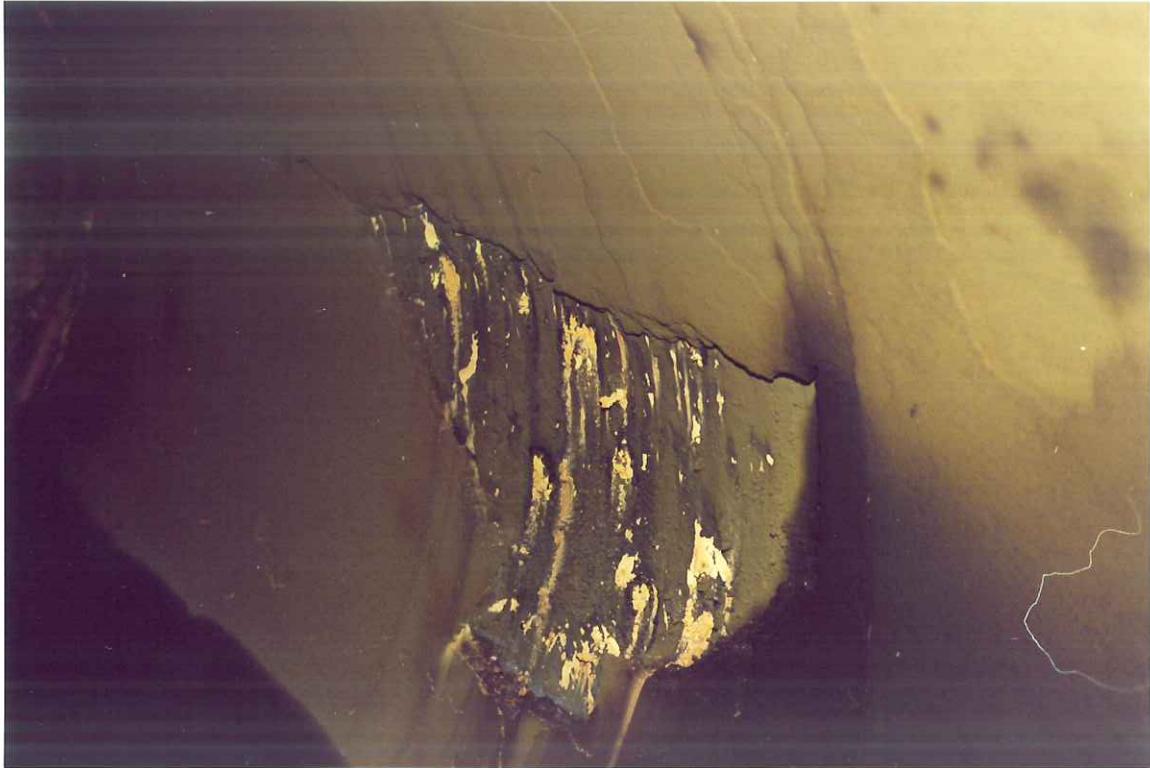
Figure 3. Spalled lining on the east side of the steel special next to the 2 meter by 1.5 meter reducer opposite valve #7, K0-260.

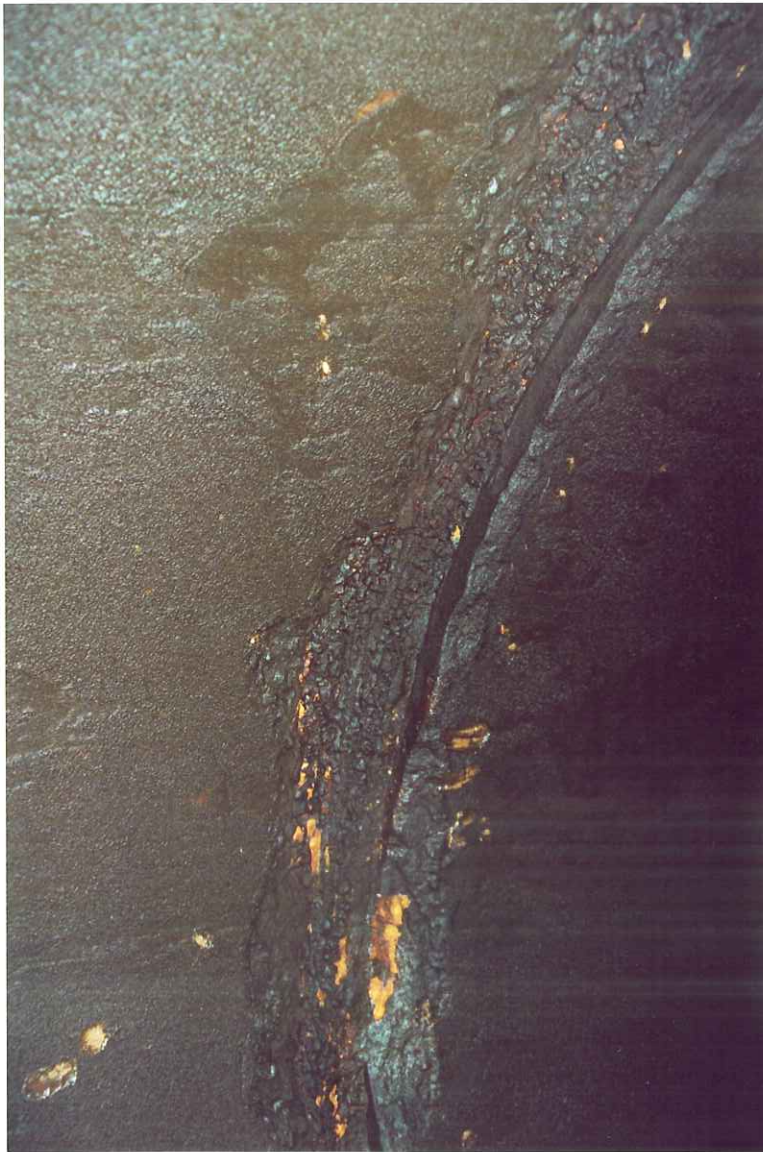
The 14th joint north of the entry port at K0+539 had spalled joint mortar and concrete lining. The distress starts about 0.3 meter below the west springline and extends across the crown to 0.6 meter below the east springline. Figure 4 is of the spalling above the east springline while Figure 5 shows above the west springline. No joint movement was associated with the spall which might have occurred during installation. Repair of the joint is recommended.

Figure 4. Spalled joint above the east springline of the 14th joint north of the entry port at K0+539.

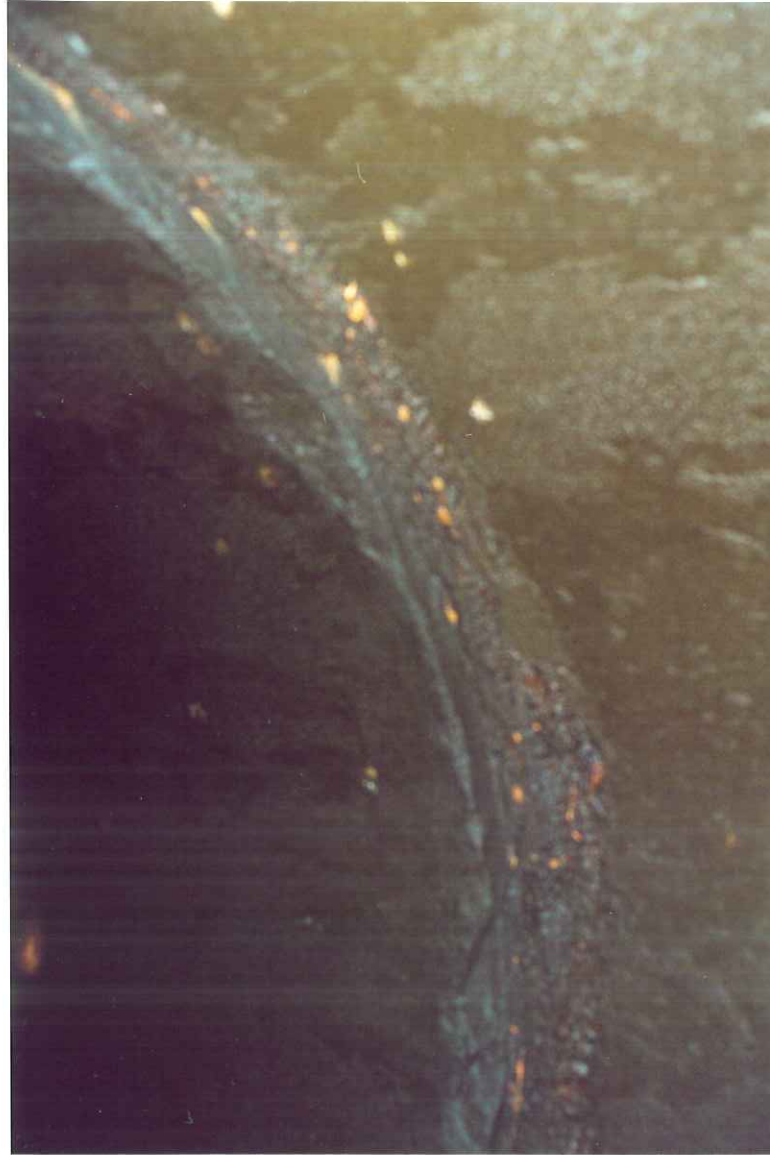
Figure 5. Spalled joint above the west springline of the 14th joint north of the entry port at K0+539.

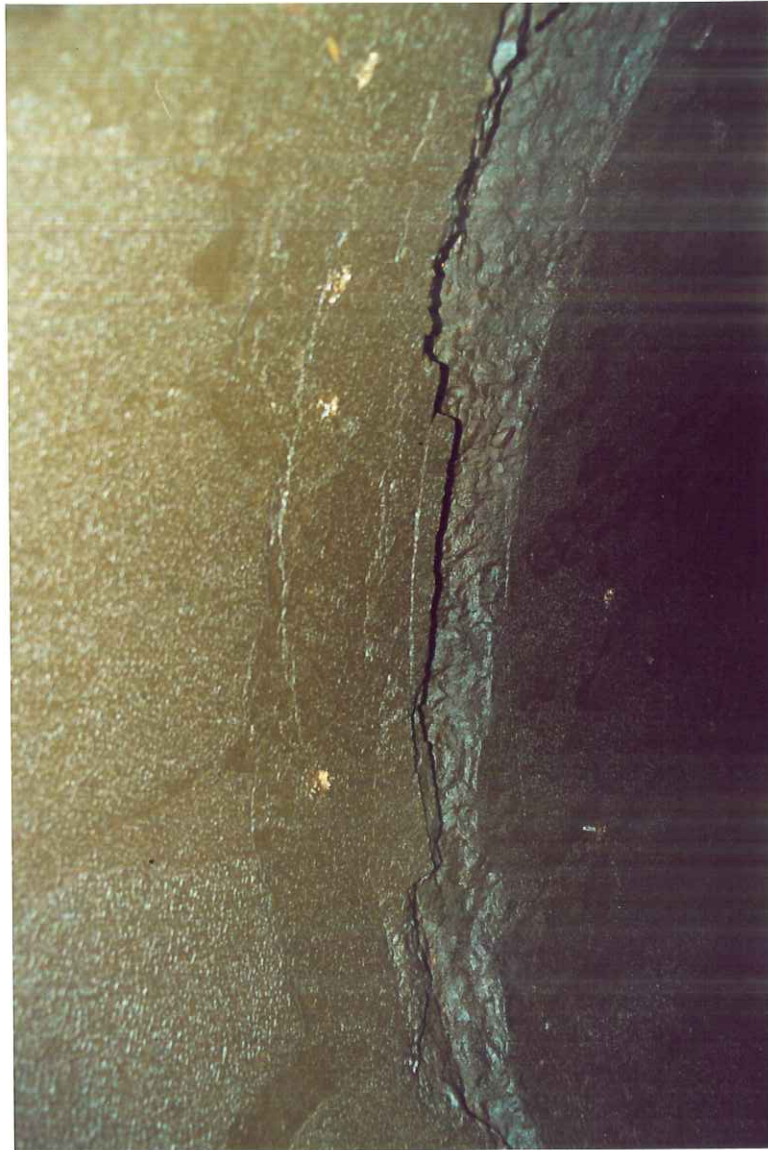
Figures 6 and 7 show the joint spall and cracked concrete lining above the east and west springlines, respectively, at the 25th joint north of the blow-off at K0+794±. There was a joint

opening of approximately 2.5 centimeters at the invert that narrows to zero at the crown, indicating that the damage might have resulted from settlement. The joint should be repaired.

Figure 6. Spalled joint above the east springline of the 25th joint north of the blow-off at K0+794±.

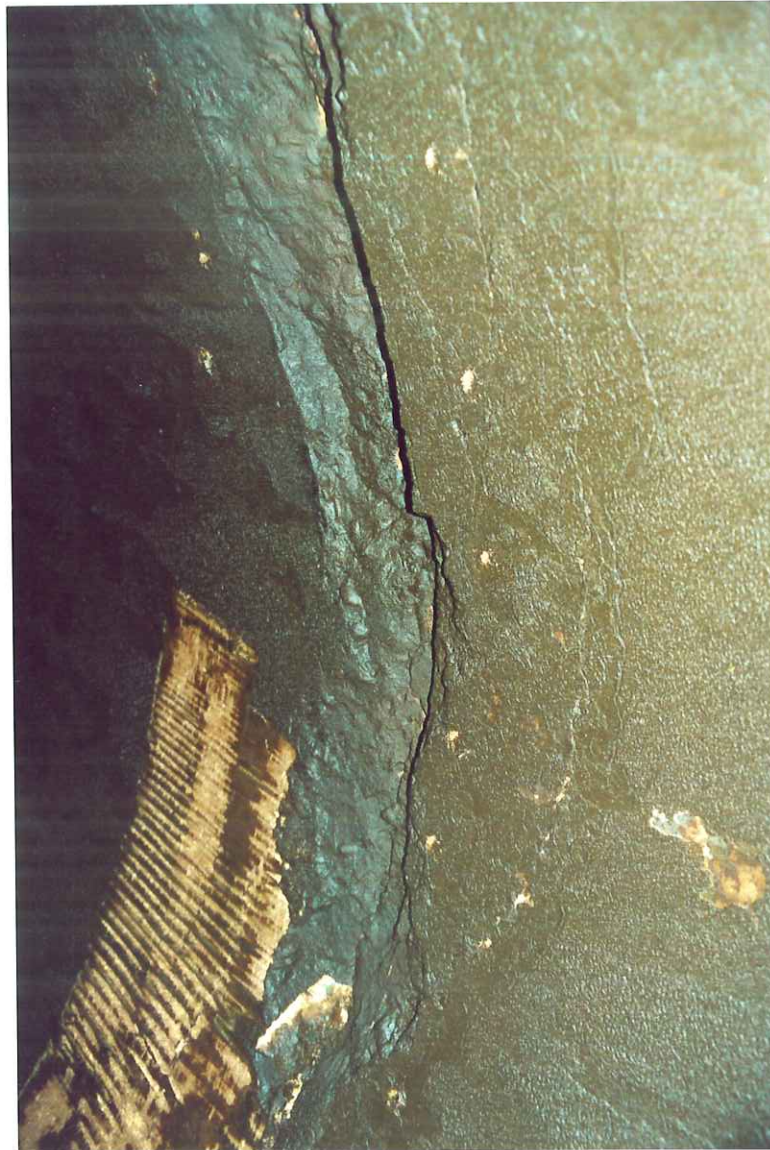
Figure 7. Spalled joint above the west springline of the 25th joint north of the blow-off at K0+794±.

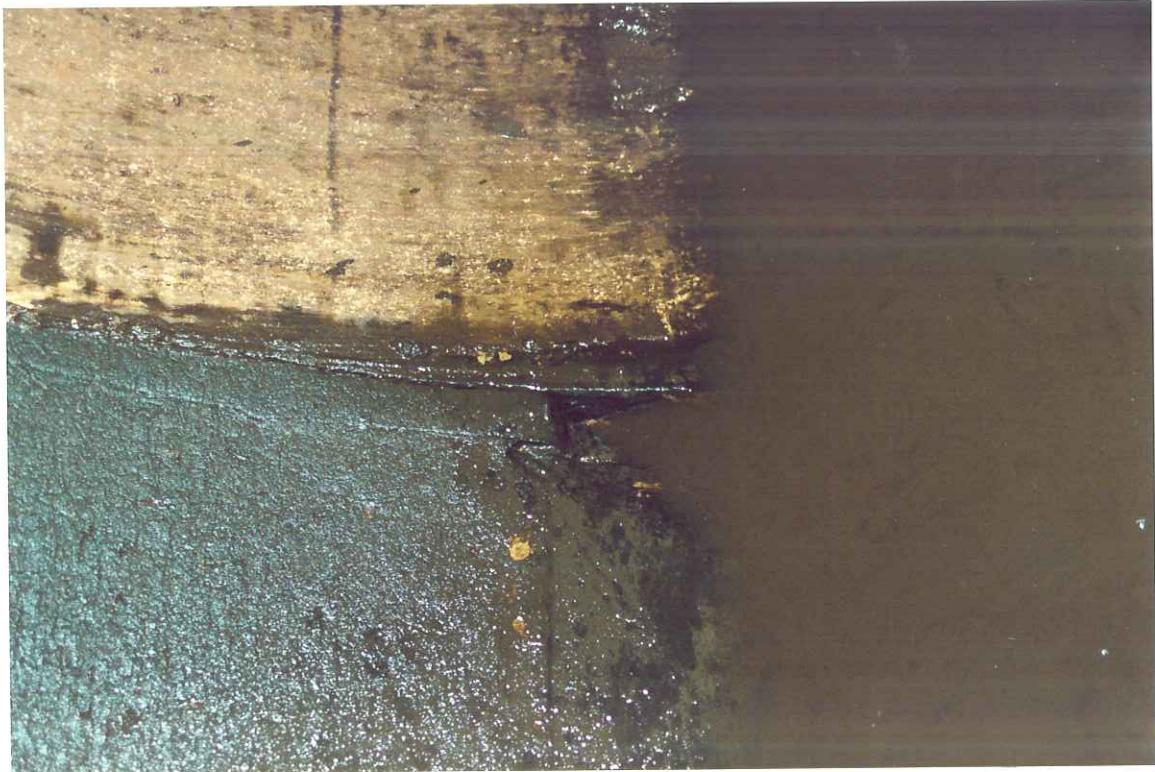
Joint mortar was missing at the invert of the 15th joint north of the entry port at K1+291. Due to the presence of standing water at the joint, the lack of joint mortar is barely visible at the edge of the water in Figure 8. Re-pointing of the joint is recommended.

Figure 8. Joint mortar missing at the invert of the 15th joint north of the entry port at K1+291.

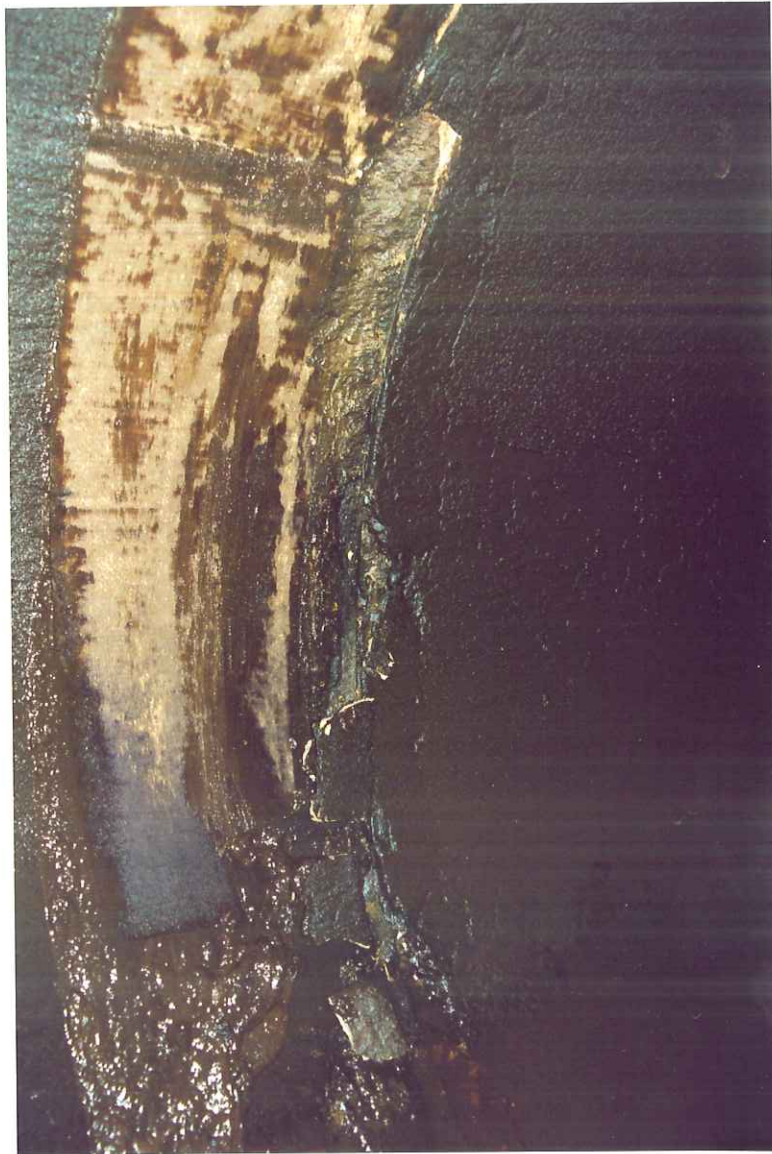
An old lining patch was noted at the 18th joint north of the entry port at K2+055. The patching was loose from springline to springline across the invert. Figure 9 shows the joint below the west springline while Figure 10 is of east haunch and invert. Disruption of the lining patch might have occurred during pipe installation. Loose or spalled patching material should be removed and the joint repaired.

Figure 9. Loose patch below the west springline at the 18th joint north of the entry port at K2+055.

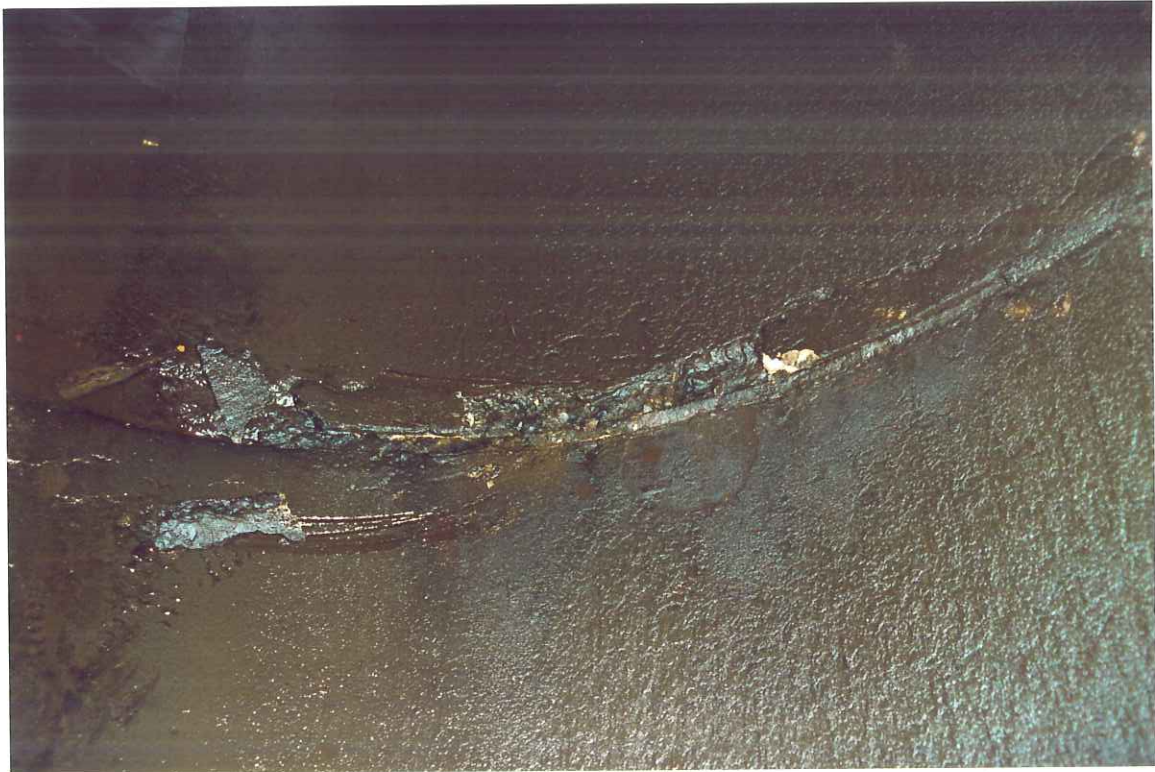
Figure 10. Loose patch below the east springline at the 18th joint north of the entry port at K2+055.

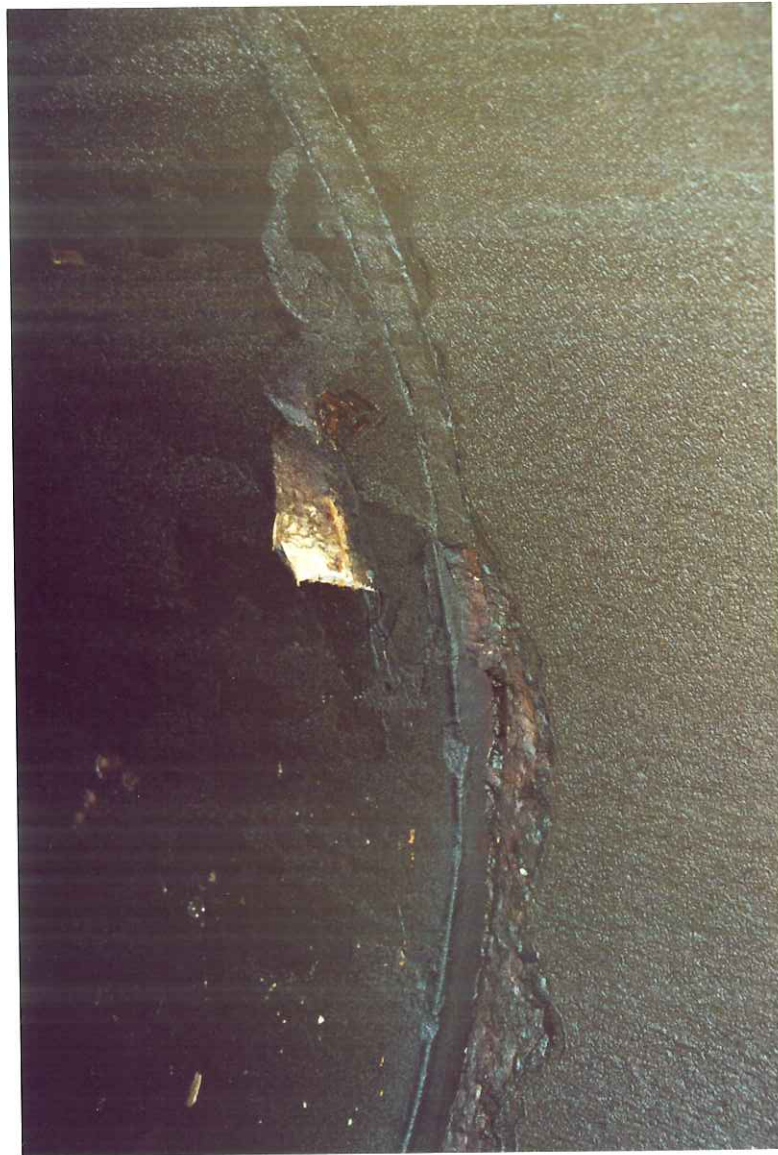
The joint at the north end of the steel plate special with entry port at K2+952 exhibited spalling from the invert to just above the springlines. Figure 11 shows the spall below the west springline while Figure 12 is of the east springline. The lining of the steel plate special was hollow. Repair of the spalled joint mortar and lining is recommended.

Figure 11. Spalled joint mortar and lining patch below the west springline at the north joint of the steel special with entry port at K2+952.

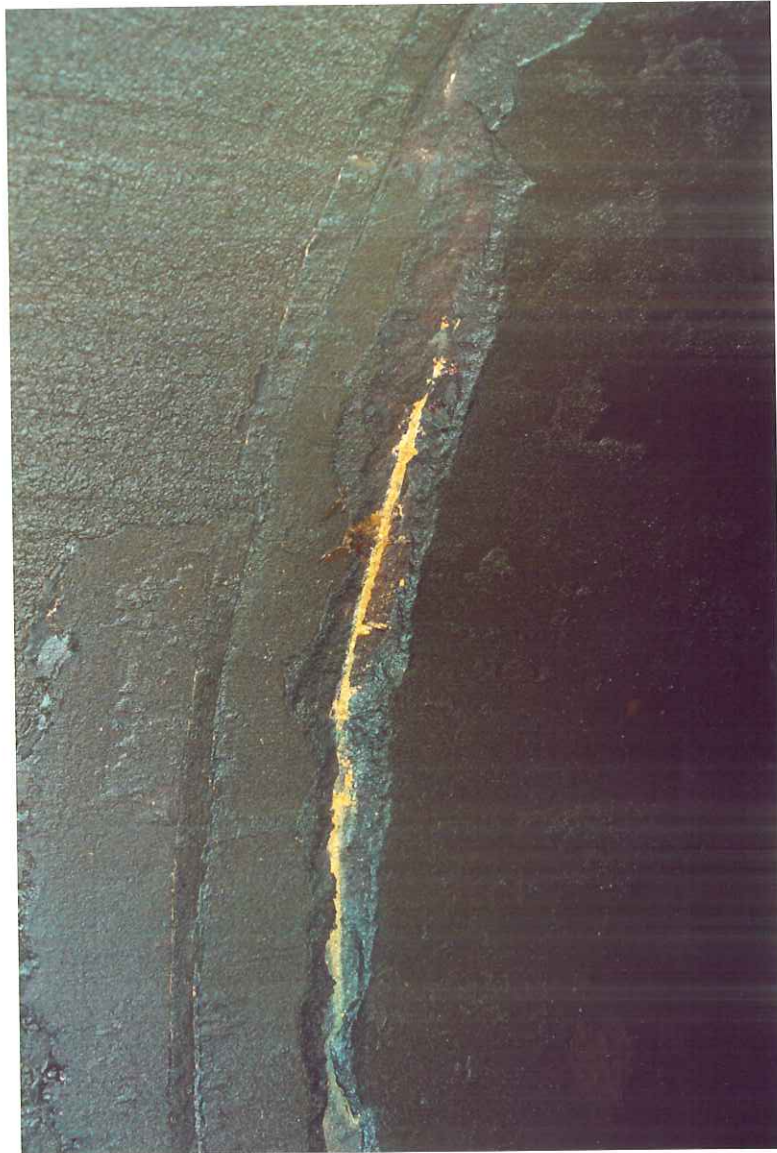
Figure 12. Spalled joint mortar and lining patch at the east springline at the north joint of the steel special with entry port at K2+952.

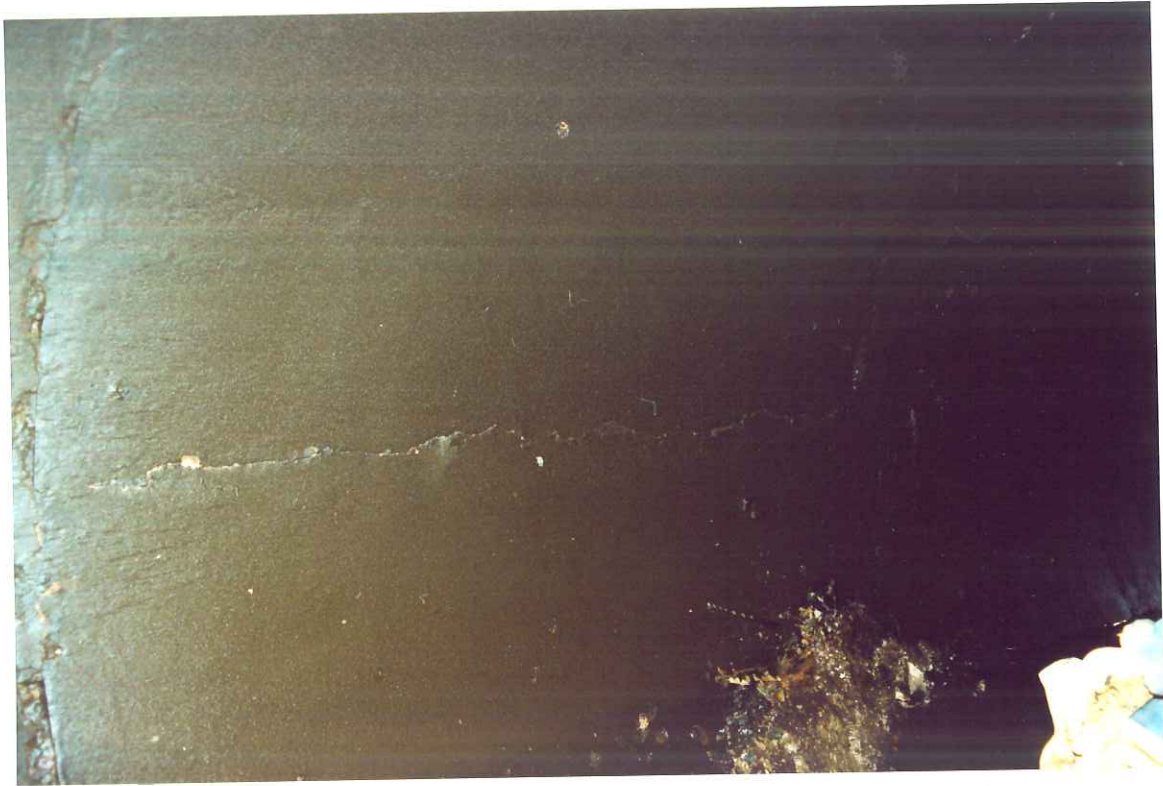
The failure repair was located 43 to 44 joints south of the entry port at K3+856. A steel plate special short and steel closure were utilized to replace a failed section. Linings of both specials was found to be cracked and hollow. Figures 13 shows cracking of the lining at the east side of the northern special while Figure 14 is of the crack on the west side.

Figure 13. Cracked and hollow lining on the east side of the northern steel short at the failure location 43 to 44 joints south of the entry port at K3+856.

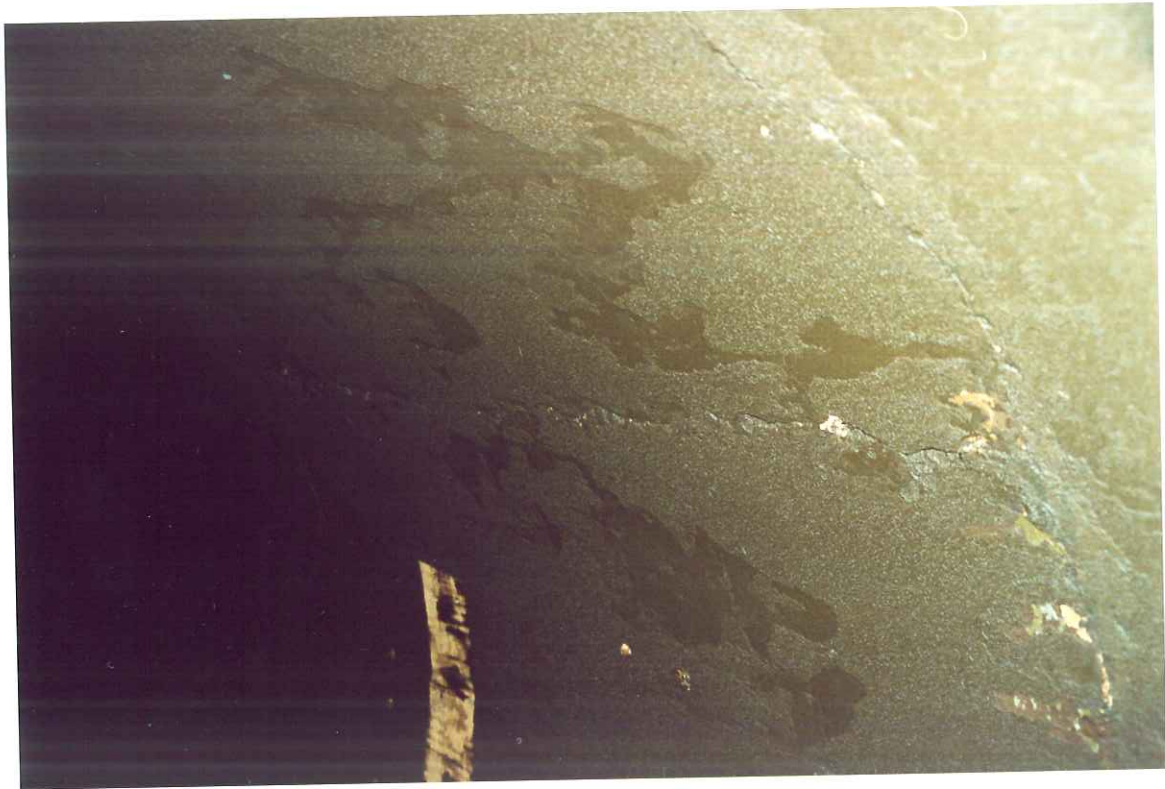
Figure 14. Cracked and hollow lining on the west side of the northern steel short at the failure location 43 to 44 joints south of the entry port at K3+856.

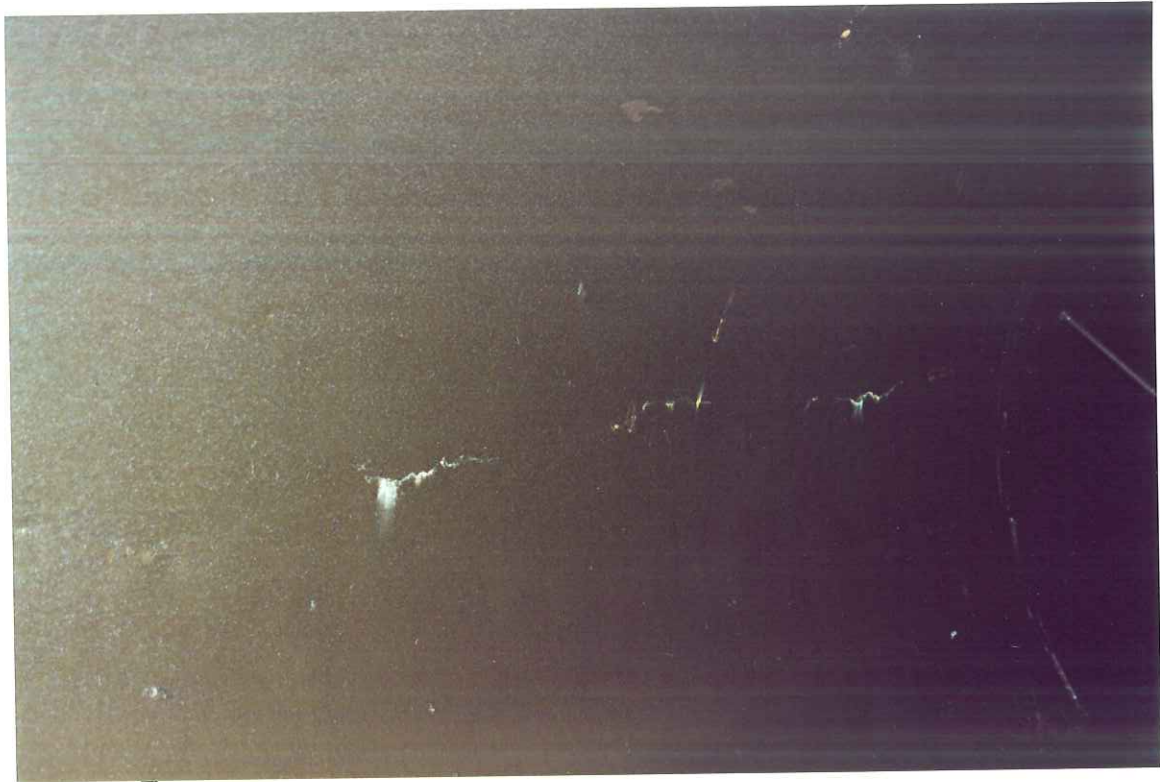
Figure 15 is of a longitudinal crack in the lining of the southern steel plate special. In the photograph traces of carbonate can be seen intermittently along the crack.

Figure 15. Cracked and hollow lining on the east side of the southern steel short at the failure location 43 to 44 joints south of the entry port at K3+856.
