A FIRST STAGE REPORT PREPARED FOR
EMPRESA DE ACUEDUCTO Y ALCANTARILLO DE BOGOTA ESP

STABILITY OF THE UPSTREAM SLOPE
OF THE
SAN RAFAEL DAM, BOGOTA

Jason Consultants International Inc

JANUARY 17TH 2000

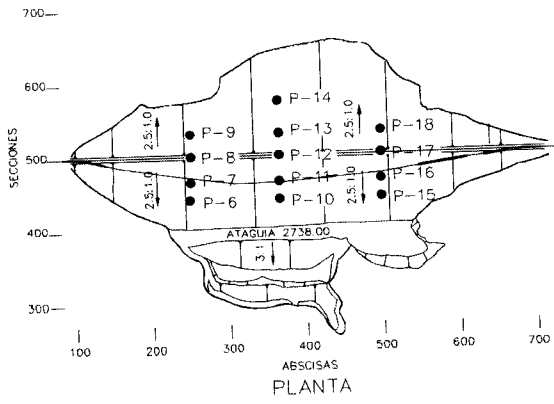
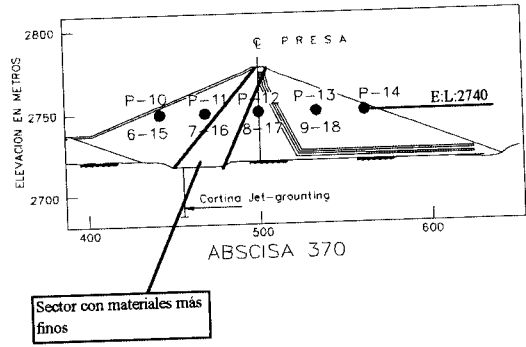
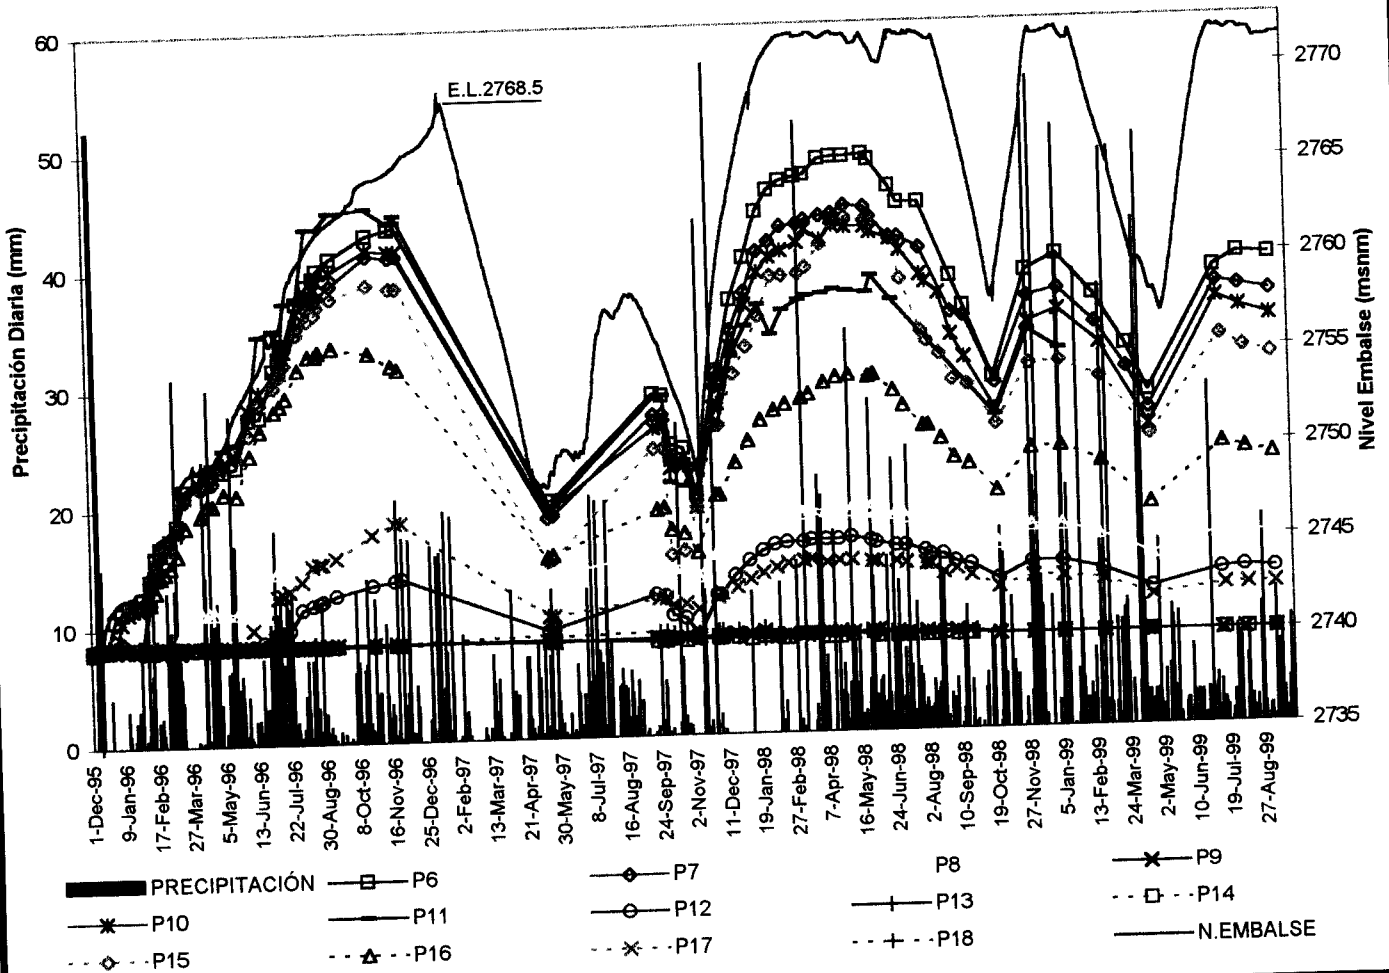
FIGURA No. 11

- 4.6 Results for piezometers P-10 and P-11, given in Figure 11 of Documento CHSR-IM/004-044 and reproduced here in Appendix B, suggest that drawdown of the phreatic surface in the Zone 1 fill is instantaneous and almost exactly follows drawdown of the impounded water level. This seems unlikely if the coefficient of permeability of the Zone 1 fill assumes the Ingetec S.A design value of 6×10^{-6} cm/s.

- 4.7 With any piezometer system there is a finite lag time between the recorded and true piezometric level. Consequently, actual phreatic levels tend to be higher than recorded levels. So, for design, it is prudent to assume a high phreatic surface associated with sudden drawdown as is the case in Talren file RANA2.

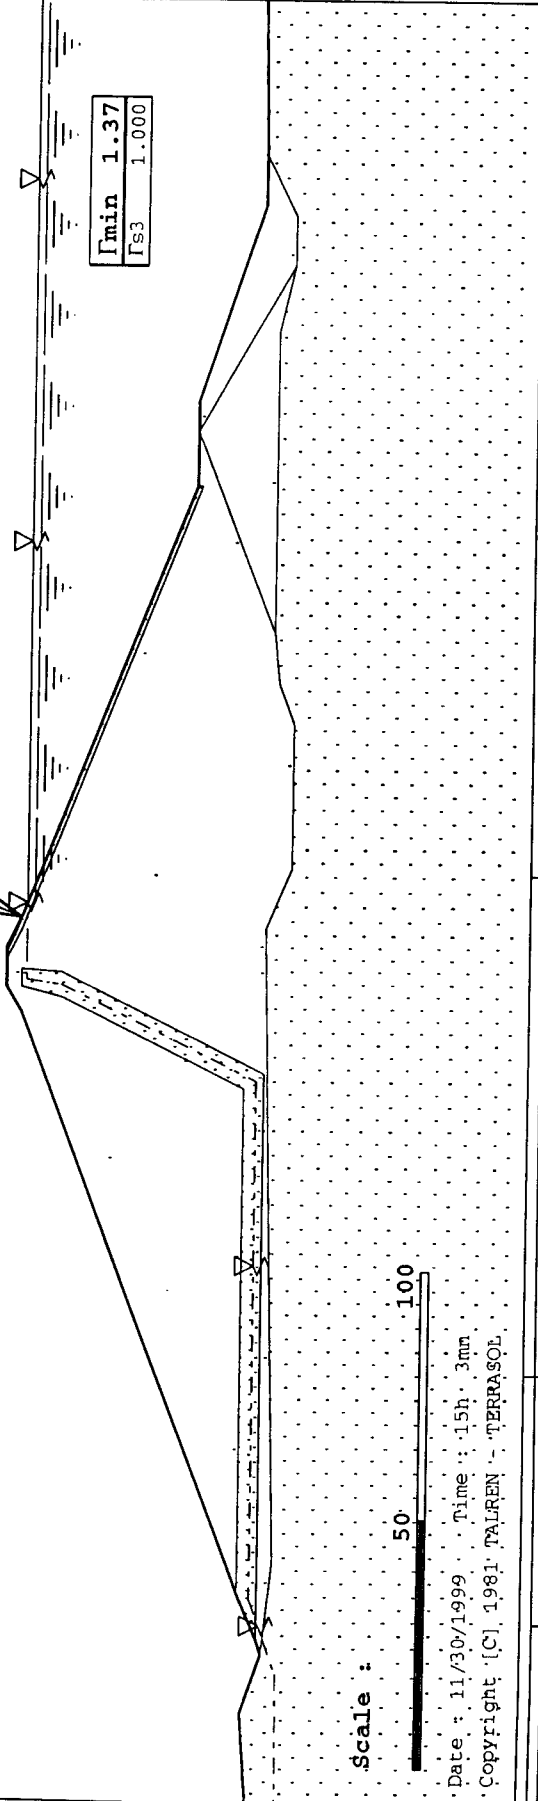
File: RANAI

- 4.3 Talren file RANA1 considers rotational stability of the upstream slope, with water impounded to the maximum level of 2772.00, and returns a minimum detected calculated factor of safety of 1.37. The critical slip surface falls above the water line, on the 1:2.0 batter, so indicating calculated factors of safety greater than 1.37 below the impounded water level.

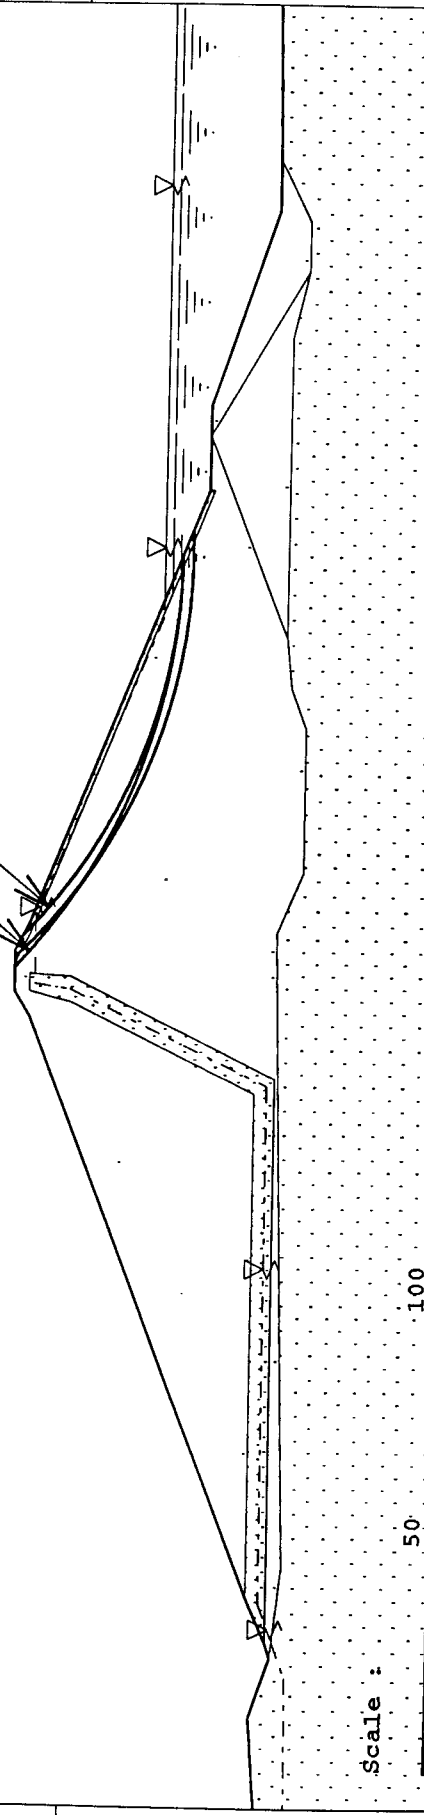
File: RANA2 Proj: SANRAPHA

- 4.4 Talren file RANA2 considers rotational stability of the upstream slope with the impounded water level drawn down to a minimum recorded level of 2748.36. Based on the assumed Ingetec S.A Zone 1 fill ϕ' value of 32° and coefficient of permeability of 6×10^{-6} cm/s, the draw down is considered to be sudden and so the phreatic surface in the upstream slope, above a level of 2748.36, is considered to lay immediately below the riprap. These assumptions lead to a minimum detected calculated factor of safety of 0.91 which implies failure.

- 4.5 Clearly, no such failure has occurred and this suggests that either the phreatic surface within the Zone 1 fill is drawn down in sympathy with the impounded water level and/or the actual ϕ' value is greater than

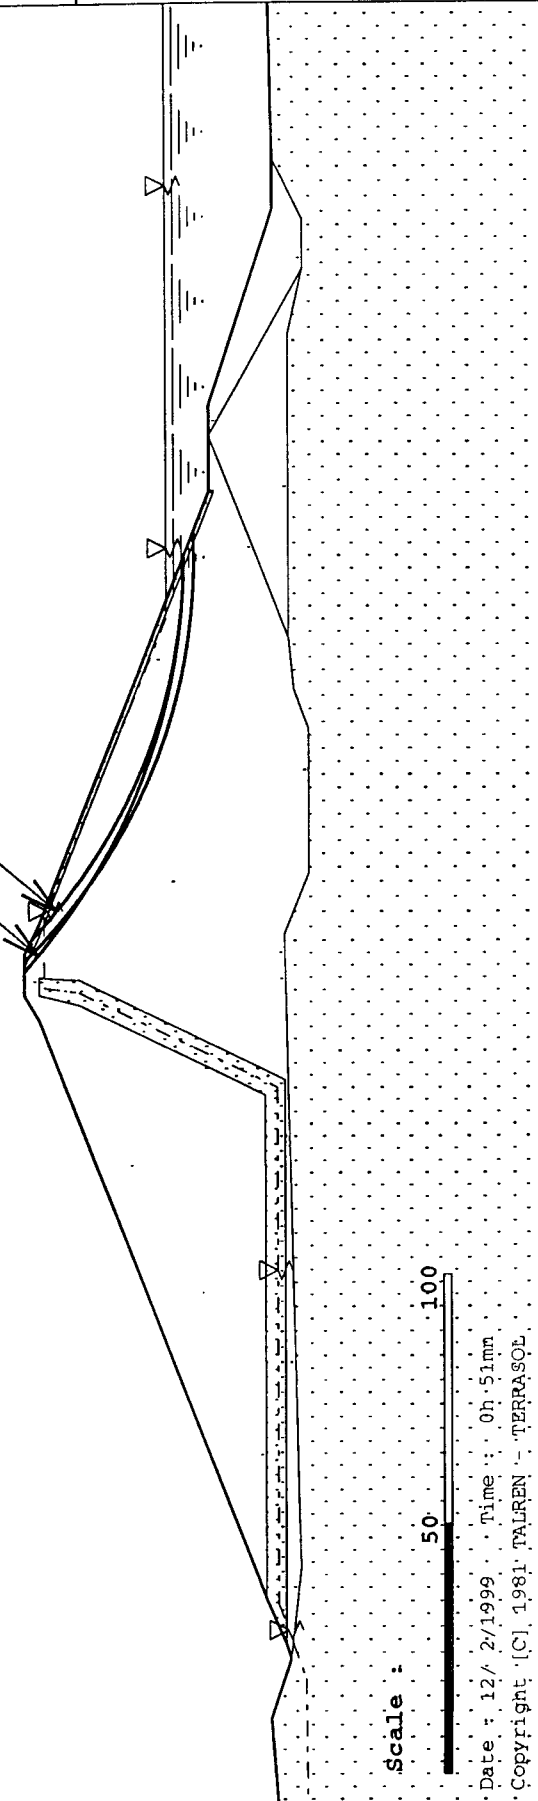
STATIC ANALYSIS OF UPSTREAM SLOPE
 MINIMUM RECORDED WATER LEVEL 2748.36
 RAPID DRAWDOWN SCALE 1:1500
 File: RANA2A Proj: SANRAPHA

- 4.10 Like Talren file RANA2, Talren file RANA2A considers rotational stability of the upstream slope with the impounded water level drawn down to a minimum recorded level of 2748.36 and a phreatic surface in the upstream slope immediately below the riprap. However, in RANA2A the ϕ' value has been increased by 3° from 32° to 35°. The effect of this small increment in ϕ' is to increase the calculated factor of safety from 0.91 to 1.02 so demonstrating the sensitivity of calculated stability to small changes in ϕ' .

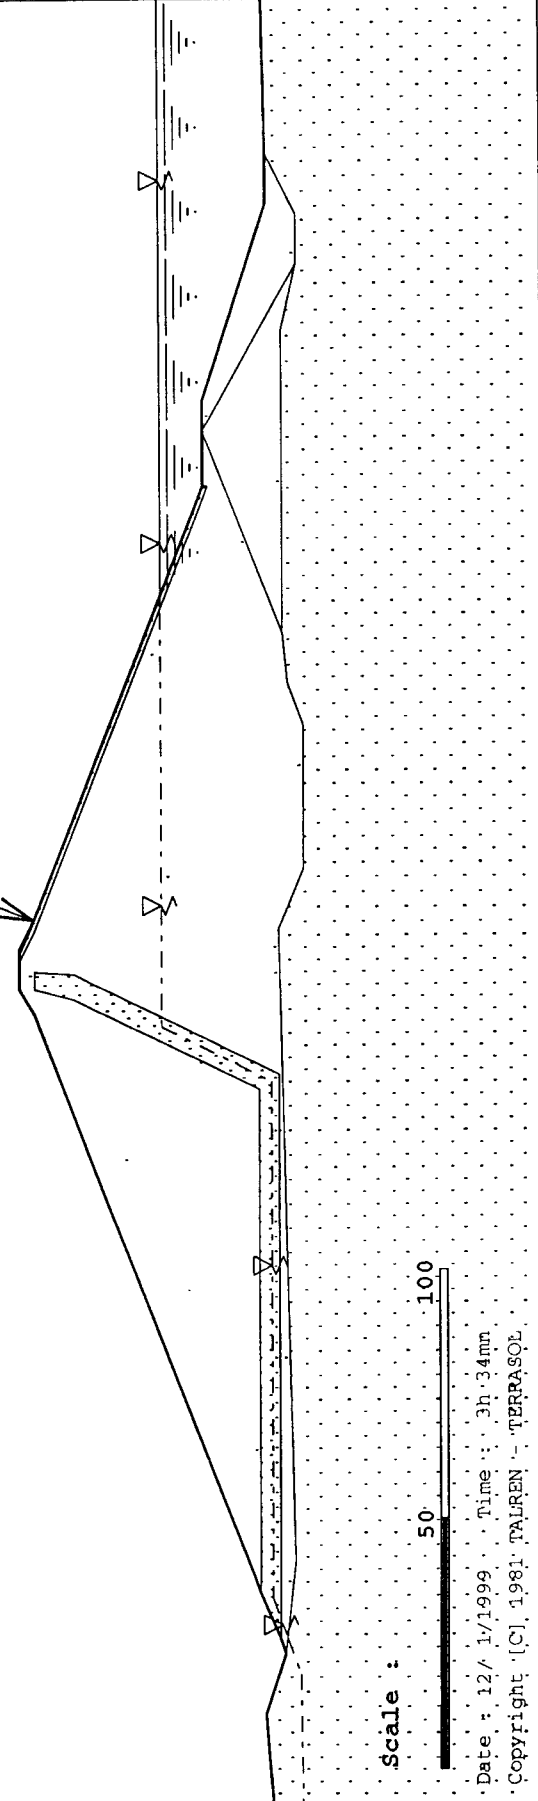
STATIC ANALYSIS OF UPSTREAM SLOPE
 MINIMUM RECORDED WATER LEVEL 2748.36
 DRAWDOWN PER PIEZO P10 & 11 SCALE 1:1500
 File: RANA3 Proj: SANRAPHA

- 4.11 Talren file RANA3 again considers rotational stability of the upstream slope with the impounded water level drawn down to a minimum recorded level of 2748.36 but in this analysis the phreatic surface

within the upstream shoulder of the dam is also assumed to be drawn down to a level of 2748.36. As expected, these assumptions lead to a minimum detected calculated factor of safety of 1.37 with the critical slip surface falling near the crest of the dam where the slope batter increases to 1:2.0.
