REPAIR & STRENGTHENING OF PCCP CONCRETE PIPE WITH CARBON FRP

Name: San Juan Generating Station, PNM
Type: Industrial Facility
Location: Farmington, NM
Completed: October 2007

CARBON FRP RETROFIT OF CONCRETE PIPES IN NUCLEAR POWER PLANT

Carbon Fiber Composites for Concrete Repair
UNIQUE FRP TECHNOLOGY
USED TO REPAIR AND STRENGTHEN
MUNICIPAL AQUEDUCT SYSTEM

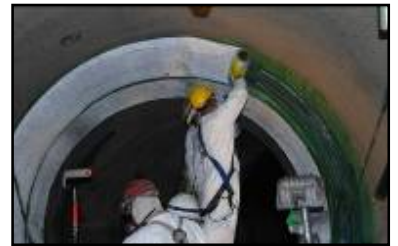
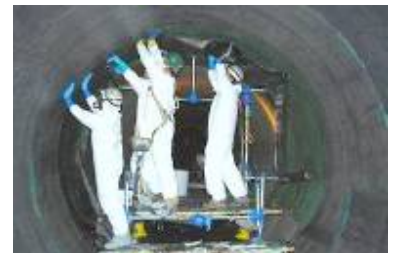
A special PipeWrap™ Carbon fabric was developed for this project to achieve the strengthening requirements with a **single layer** of fabric – instead of **two layers** as the original design called for. Samples were constructed and tested to demonstrate the feasibility of the solution. 50-inch wide bands of fabric were applied in the hoop direction, with a single overlapping joint along the bottom of the pipe. There was a small steel section in the pipe; that was wrapped first with a layer of glass fabric (shown on the right) to avoid galvanic corrosion. The entire repaired section was coated with a layer of high chemical resistant coating.

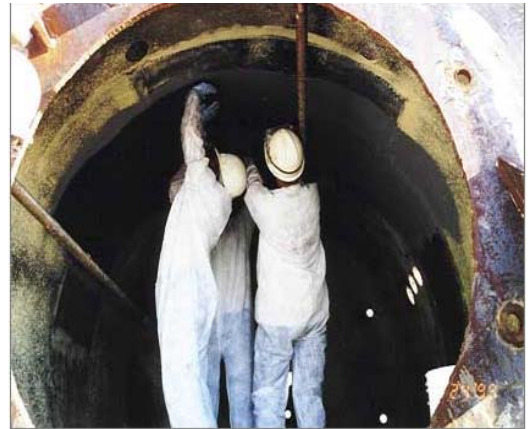
A major Nuclear Power Plant in the U.S. uses 9-ft diameter Prestressed Cylindrical Concrete Pipes (PCCP) to carry water throughout the plant. Inadequate cover concrete caused corrosion of Prestressing cables in many pipes. Replacement of the pipes required significant downtime that was unacceptable to the plant operators.

To minimize downtime, excavation was not desirable, so a repair system had to be designed to repair the concrete pipes from the inside.

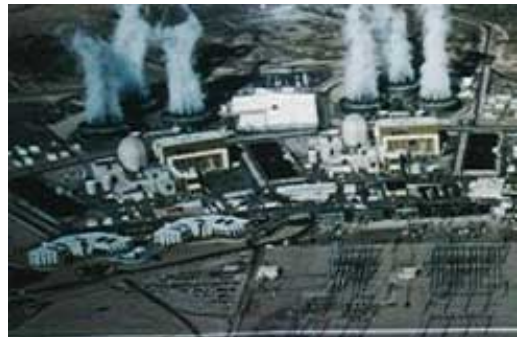
QuakeWrap developed a very strong biaxial carbon fabric through the PipeWrap™ division. The FRP fabric was specially designed and manufactured for this project to allow repair of the pipes from inside in record time and to withstand the high internal design pressures.

The nuclear power plant set up field tests of the FRP retrofitted concrete pipe and the tests were stopped when the internal pressure exceeded the original design value. This proved that the FRP repair system could also be used as a strengthening procedure.
