Arterial Aqueduct Providence, RI USA

Water Systems Category

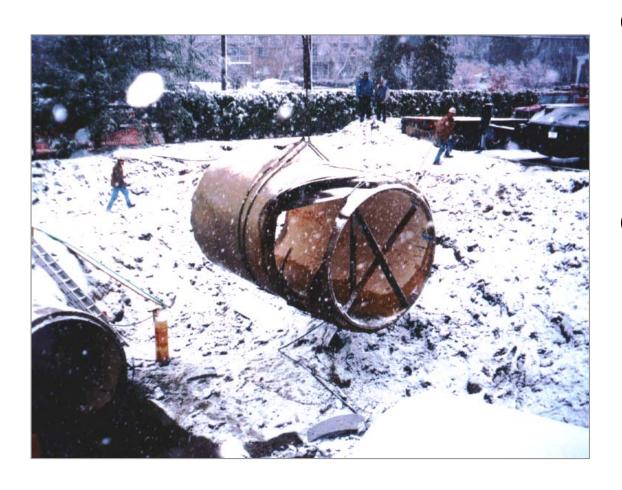
Corrosion Damage

- Corrosion of PT lead to complete failure of PCCP
- Only certain sections of pipe were effected
